## CASE STUDY 3A – EAST ANGLIA, UK

**Case study area:** East Anglia, UK

**Main geomorphological types:** Soft cliffs, shingle and sandy beaches, shingle spits, creeks, estuaries and saltmarsh.

**Main coastal change processes:** Coastal erosion, cliff instability, beach change.

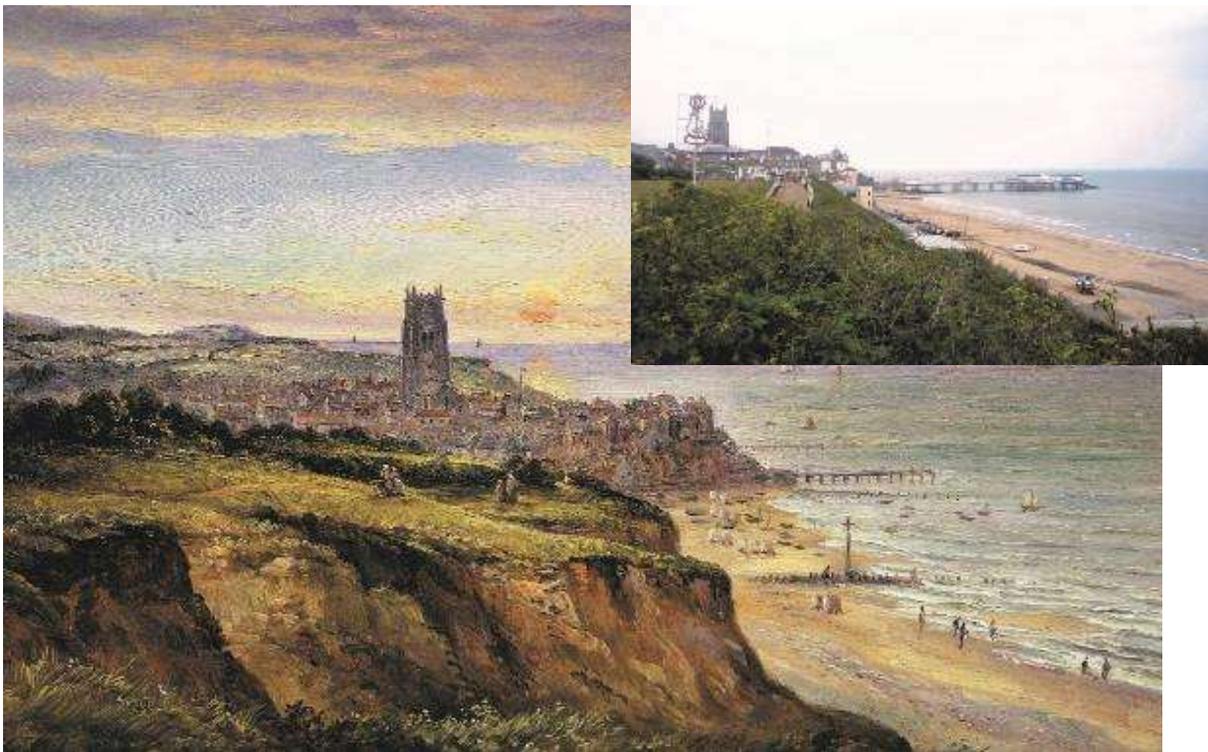
Figure 3A10. 'Cromer' by John Moore of Ipswich, c.1850, oil on canvas. Photography courtesy of Mandell's Gallery, Norwich. Private collection.

For this case study there are two paintings viewing the town of Cromer from the west and from the east. In the case of the cliffs, the natural processes of cliff erosion and weathering can be clearly seen. Large sections of the 30 – 35m high cliff can be seen spalling away by a process known as mass wasting, particularly in the painting from the west. The indentations in the face of the cliff shown in the two paintings suggest that cliff conditions are influenced strongly by the local geology and groundwater conditions. The back scars of small slides and slips can be seen at the top of the cliff adjacent to the grassy land in the front of the church. These processes will have been speeded up through a lack of toe support, which is resulting in removal of support for the cliff line above by marine erosion. The artworks also illustrate how the steep clay cliffs are attempting to re-grade naturally to a more stable angle of repose by the processes of slope failure. The accumulation of slope debris at the foot of the sea cliffs is, however, being quickly removed by coastal erosion and as a result the cliff face is unable to achieve equilibrium, and therefore, remains actively unstable.

Also of interest is the depiction of the beach, which shows the extent of the sand and shingle ridges running along the beach parallel with the cliff line. The careful painting of the groynes and the pier also give an indication as to the extent of the beach and the way the sediment is being retained by the groyne, particularly in the view from the east, at that particular time. This pair of paintings can, therefore, provide useful indications of conditions prior to coastal defences being constructed. The present day views illustrate how the cliff face has become almost completely vegetated over the intervening period, largely as a result of protection at the toe by nineteenth century or earlier sea wall construction. Along part of the town coastal frontage a large car park has been constructed, which has had the effect of advancing the coastal defence line seawards, and this provides additional support for the previously unstable cliff line.

The artwork describes very clearly the conditions that were being experienced along the frontage before areas were defended. It suggests what conditions might be experienced in terms of the re-activation of cliff instability problems if coastal defences are not maintained or are removed at some time in the future. This would lead to significant toe erosion of the cliff line and instability problems, which would impact upon people, property and assets in the town.

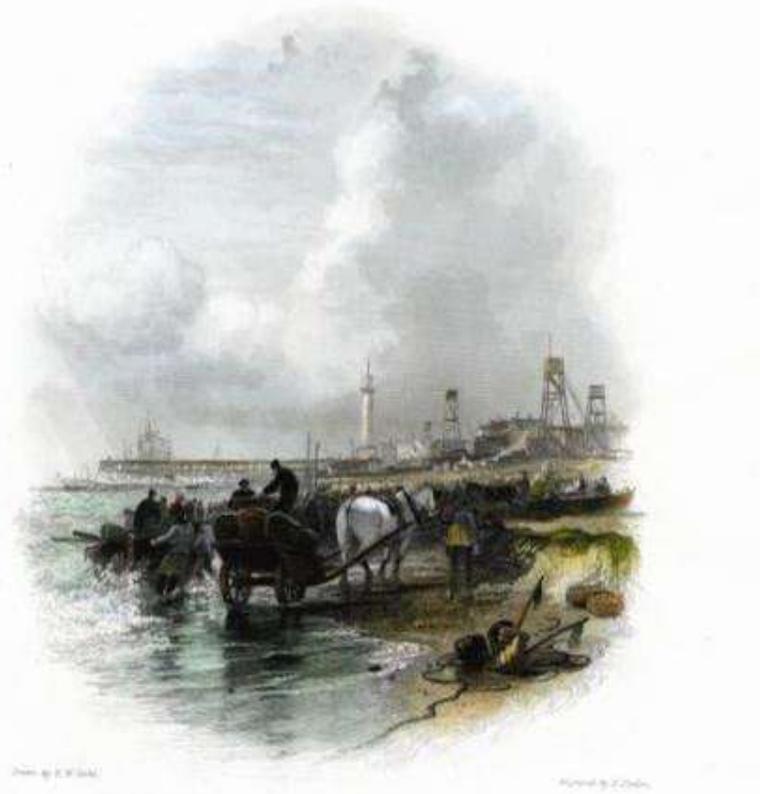
Figure 3A12. 'Yarmouth' by Edward William Cooke, RA, 1838, steel engraving

There are a large number of views taken of Great Yarmouth beach on account of the location of the fishing village on the shore adjacent to the pier. It is possible to note beach levels against the timber pier structure and make comparisons through the numerous artworks that exist of this particular location. The view by Rock & Co. Engravers, dated 21<sup>st</sup> June 1850 (Figure 3A11), shows the timber fishing jetty and beach levels at the time. This compares with the present day view, which shows the healthy condition of the beach. An even earlier view of Yarmouth Beach by Edward William Cooke RA, published 1838 (Figure 3A12), also shows the relatively low beach levels against the timbers of the jetty.

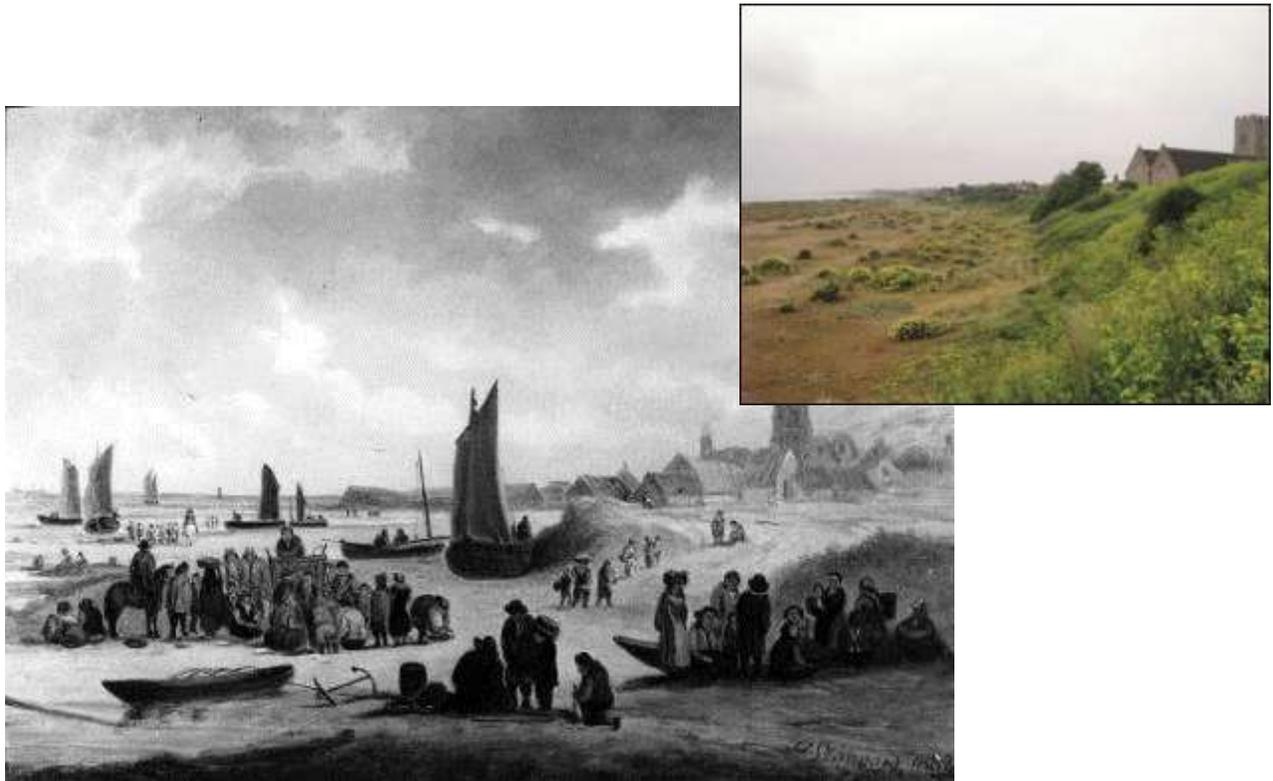
Figure 3A14. 'Pakefield' by Alfred Stannard, 1882, oil on canvas. Photograph courtesy of Mandell's Gallery, Norwich

This painting informs us of the changing beach conditions at Pakefield since the 1880s. In particular the beach appears more extensive today and the backshore and coastal cliffs appear to be extensively vegetated. This appears to be supported by evidence from coastal surveys since the 1990s, which show significant rates of accretion at the northern (Lowestoft) end although there has been some erosion at the southern end (Environment Agency, 2011).

It is necessary to continue to maintain the stable backshore and cliff line in order to protect the historic church and cliff top assets existing along the frontage. In the past the cliffs at Pakefield have been the subject of severe coastal erosion, with a number of properties being destroyed as a result of the retreat and rotational landsliding.

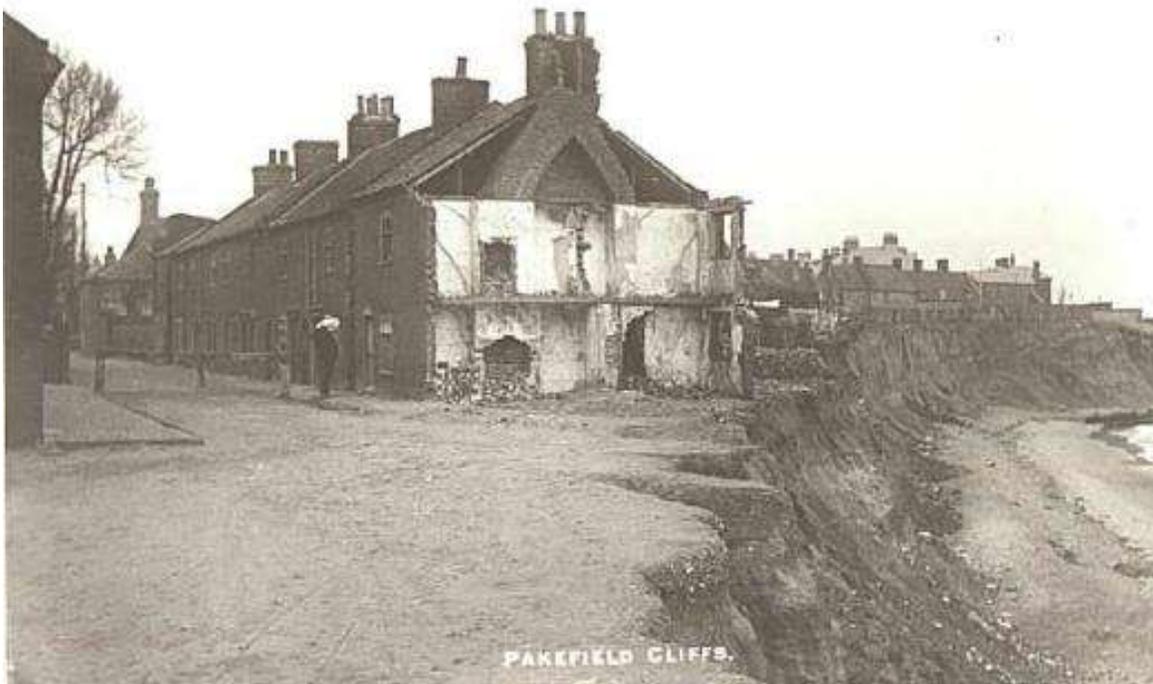
Figure 3A15. Coastal instability at Pakefield, early twentieth century

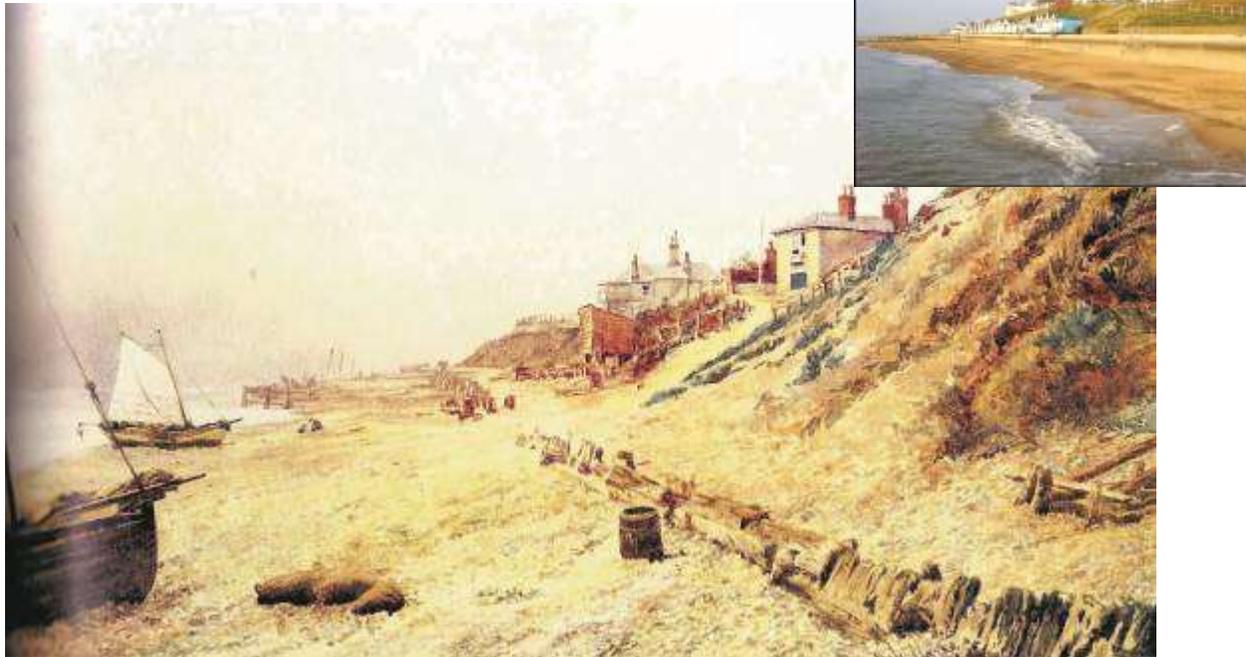
Figure 3A16. 'Southwold' by Helen Clarke, 1899, watercolour. Photograph courtesy of Derek Newman Fine Art. Private collection.

This view by Helen Clarke was painted in about 1899, and provides a detailed illustration of the conditions on the cliff line and the beach at that time. Rudimentary coastal defences line the foot of the cliff and the beach appears to be of shingle; although the more vegetated cliffs appear relatively stable in the foreground they are more susceptible to active erosion beyond. Some further coastal defences and a groyne can be seen projecting into the sea in the middle distance. The situation in 1899 can be compared with the present day view below, which shows a new concrete sea wall and re-grading and stabilisation of the coastal slope. The beach appears lower in the present day view, which may perhaps be a result of wave reflection from the hard structure causing some scour, or other factors including a reduction in the supply of sediment feeding from the north, as well as rising sea levels.

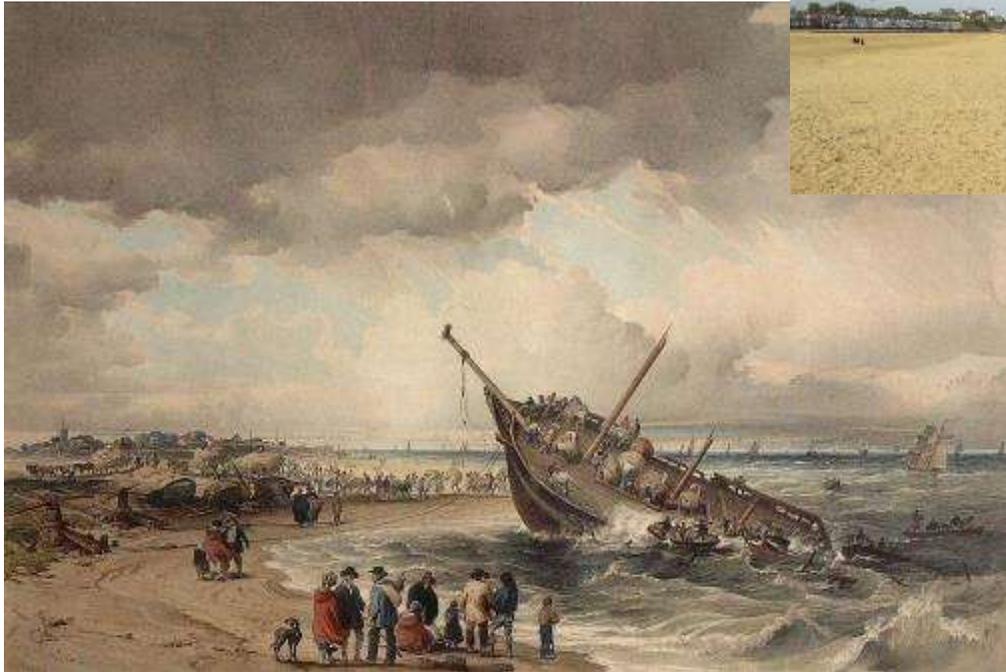
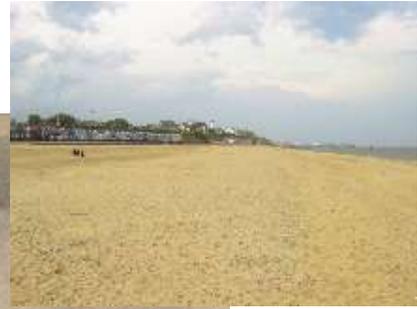
Figure 3A17. 'Wreck of the Princess Augusta on Southwold Beach' by J. B. Ladbrooke, 1838, lithograph

This view is of interest because it illustrates both beach conditions and also the occasion of the wreck of the 'Princess Augusta' on Southwold beach in October 1838. In the foreground, the wreck has taken place in a shallow bay but, overall, in the middle distance and beyond, the very extensive beach, leading toward the town of Southwold, can be seen. The southern edge of the town with some buildings and the church is visible. Beach conditions appear healthy at the time, although the whole frontage is quite low lying.

This 19<sup>th</sup> century lithograph provides us with an interesting depiction of the shipwreck set against the coastline at Southwold. It provides only a general view of the beach but together with other artworks of the location it demonstrates healthy beach conditions at the time.

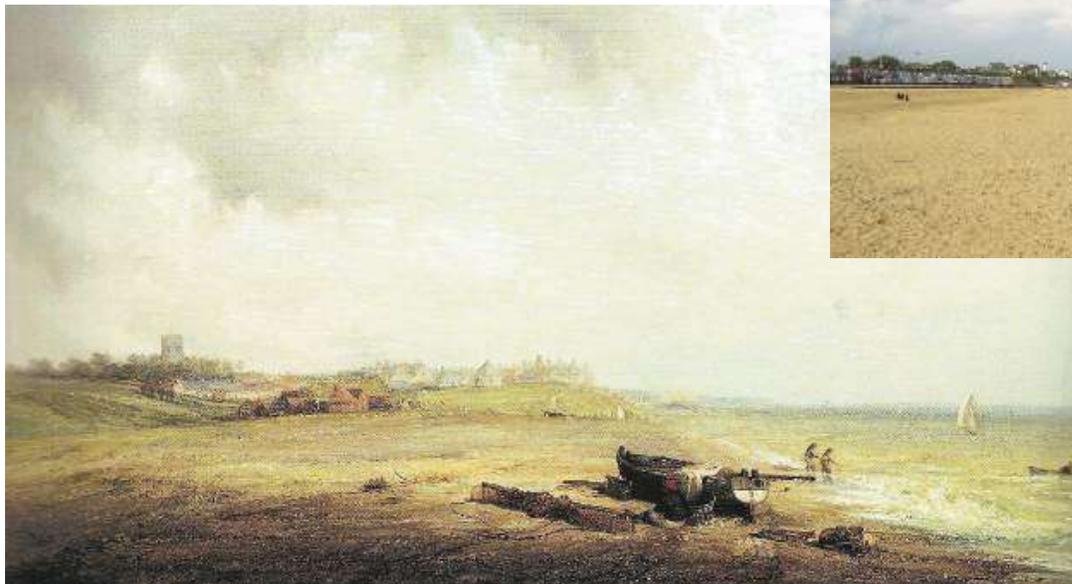
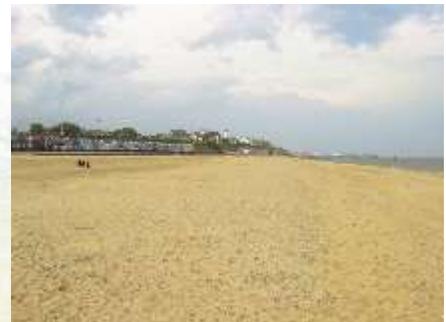
Figure 3A18. 'The beach at Southwold' by Thomas Smythe', c.1860, oil on canvas. Private collection. This view is taken from the same location as Figure 3A17

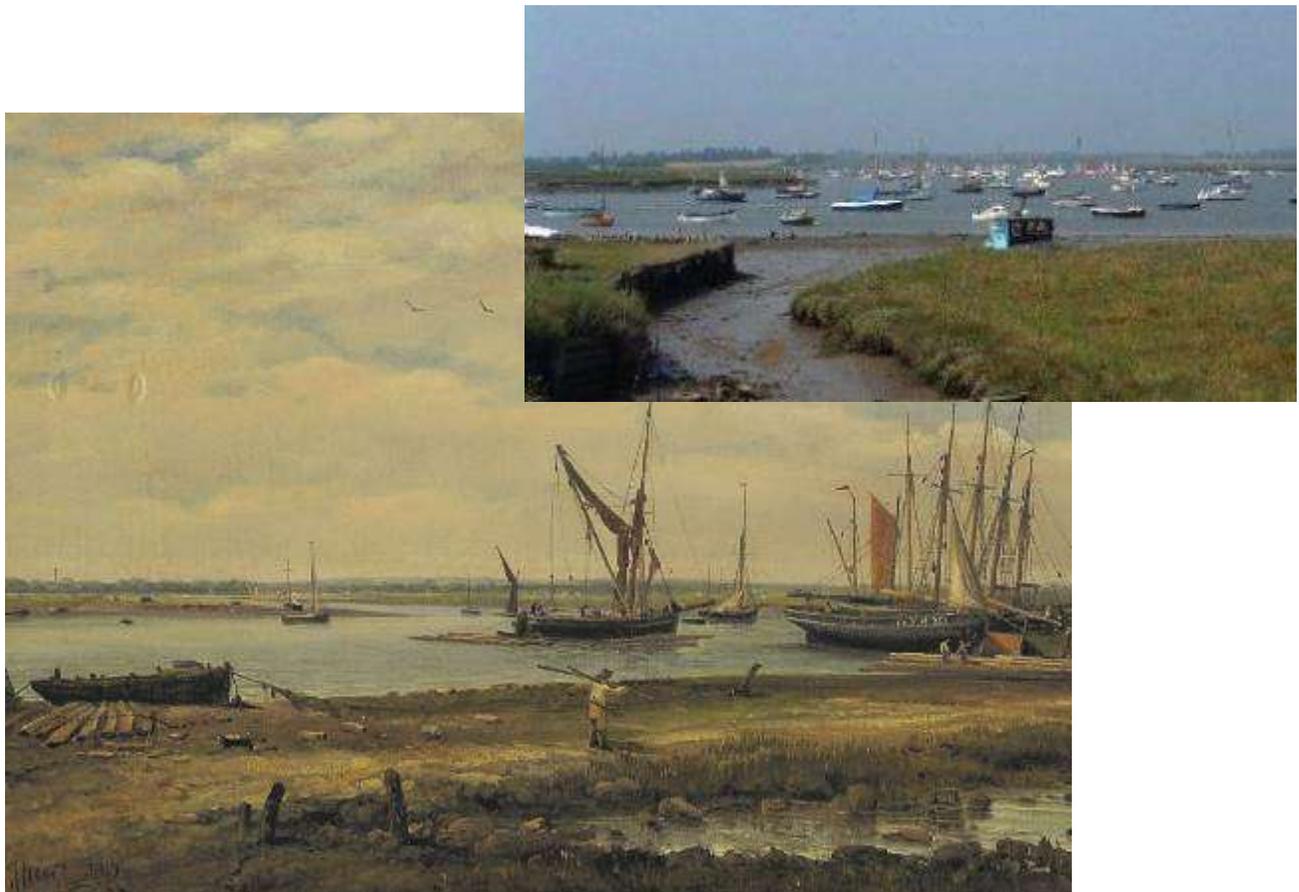
Figure 3A20. 'Slaughden Quay' by John Moore of Ipswich, 1883, oil. Photograph courtesy of Colchester and Ipswich Museums

Slaughden Quay is located on the River Alde and is situated on a massive shingle spit, which extends for some 16km south of Aldeburgh to Orfordness and Orford Beach. The shingle spit is separated from the hinterland by the River Alde, which flows eastwards, through Snape, before broadening into a wider estuary and narrowing again and turning sharply south as a result of longshore drift.

This quite detailed oil painting shows a tranquil scene at Slaughden Quay by John Moore of Ipswich, painted in 1883. The painting illustrates, in a general way, the nature of conditions at this site, which appear to have remained relatively unchanged.

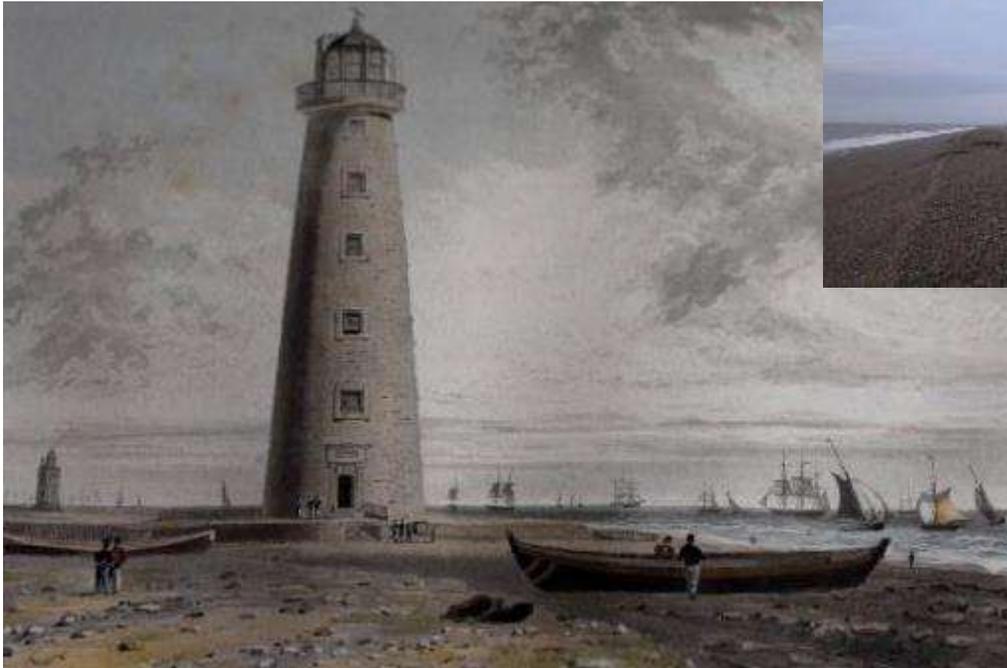
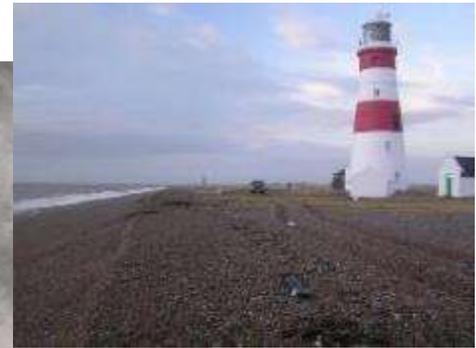
Figure 3A21. 'Orford Ness Lighthouse, Suffolk' by William Daniell, RA, 1822, aquatint. Private Collection

The site is located on a major shingle spit, which has the potential to breach between the shore and the estuary as a result of its exposed location, and particularly in the face of rising sea levels and a potential increase in the frequency of storm events. The Alde/Ore estuary runs behind this massive shingle ridge to emerge at the coast at North Weir Point to the south. The spit was formed almost entirely by waves through the process of longshore drift. The main influence has been storm waves throwing shingle over the top of the beach crest, where it is protected from the more usual wave action. Over the last two hundred years historical evidence suggests that the spit has extended southwards at between 64-183 metres per year. Over the years this leads to the formation of stable shingle ridges of finer material and swathes of coarse shingle, which may then be colonised by vegetation.

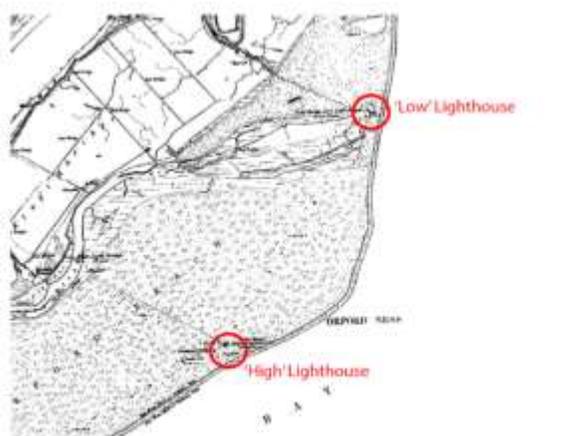
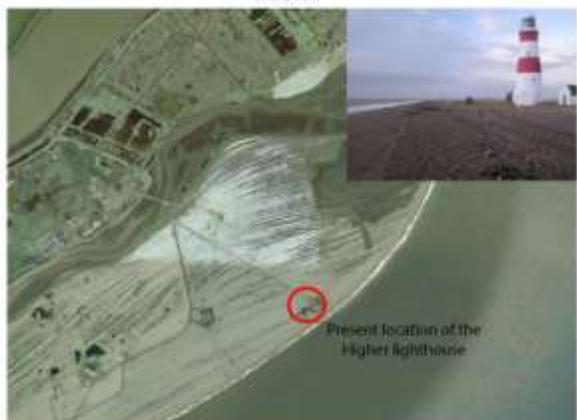
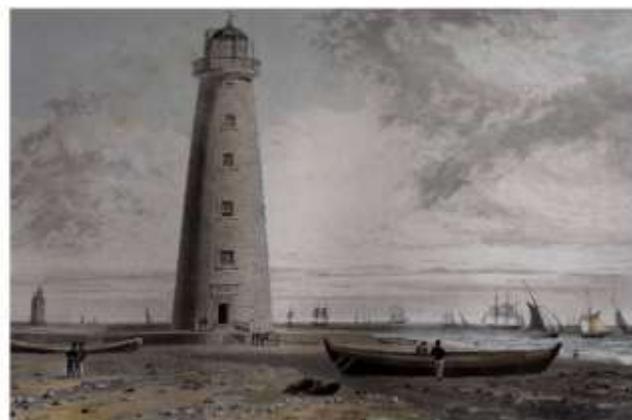
Orford Ness on 1st Edition OS Map from the 1880's. Both lights are shown

Hodkinson's map of Suffolk 1783 shows two 'lights' at Orford Ness

Current location of the higher Lighthouse, Google Earth 2013. Photo copyright Stuart Warrington.

Aquatint engraving of Orford Ness (high) lighthouse by William Daniell in 1822, the low lighthouse is shown in the distance

*Figure 3A24. The lighthouses at Orford Ness depicted in 1783, 1822, 1880 and 2013. Such features are often depicted in historic maps and paintings and are good reference points when illustrating coastal change*

The area of Orford Ness is another good example of combining art, maps and heritage features to understand coastal change. Two timber light towers were constructed at Orford Ness in 1637, known as the High and Low lights, affected by coastal erosion they were replaced by brick towers in 1720 and 1792, but by 1887 the lower light was lost to the sea. The higher light can still be seen today, however, in June 2013 the lighthouse was decommissioned due to the threat of erosion, the following maps and paintings depict the lighthouses and coastline at various periods (Figure 3A24).
