CASE STUDY 3B – KENT, UK

Case Study Area: Kent, UK

This case study report is part of the technical report on the Arch-Manche project, which quantifies the value of under-used coastal indicators that can be applied as tools to inform long term patterns of coastal change. In addition, it provides instruments to communicate past change effectively, model areas under threat and interpret progressive coastal trends.

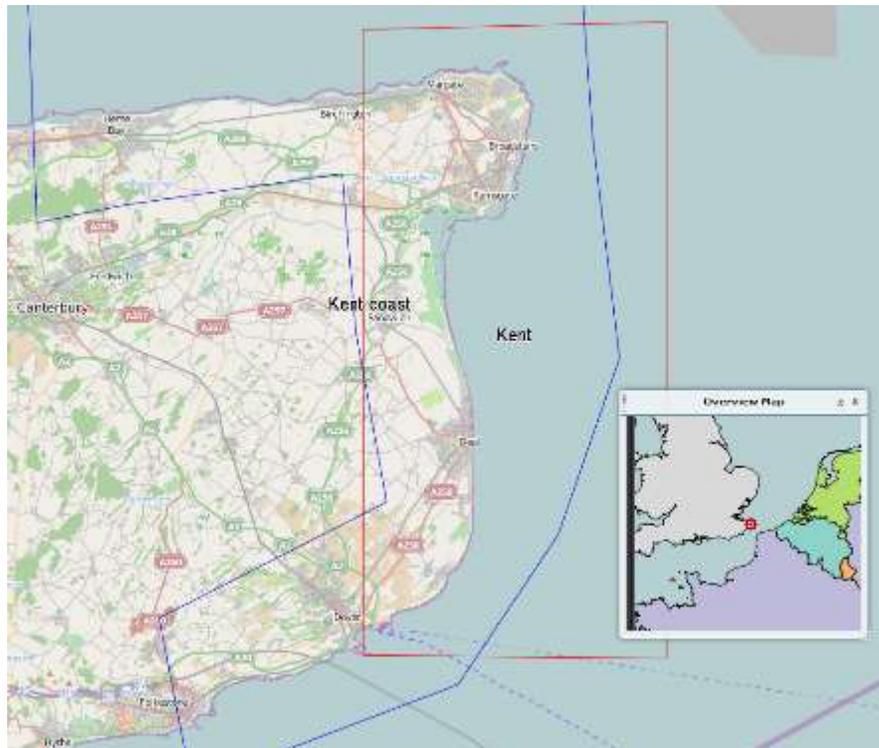
Figure 3B1. Map of the Kent study areas, the archaeological area is shown in red and the art area in blue.

Within the Kent area the archaeological and palaeoenvironmental resource and the available art resource have been researched, ranked and analysed. The extents of the detailed study areas are shown in Figure 3B1 below. The area considered for archaeology and palaeoenvironment has been selected to provide a representative range of types of evidence across time spanning from the Palaeolithic through to more modern coastal heritage. The art, photograph and map case study area encompasses a broader stretch of the coastline to reflect the various coastal morphologies and features which have been depicted over time.

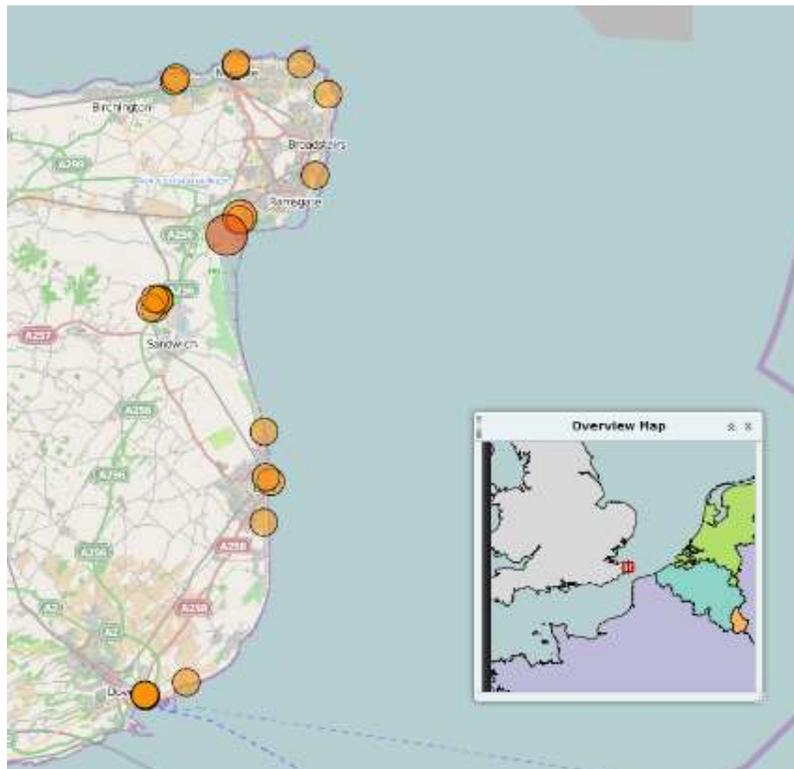
Figure 3B3. Map showing the distribution of highest ranking archaeological and palaeoenvironmental sites within the Kent study area.

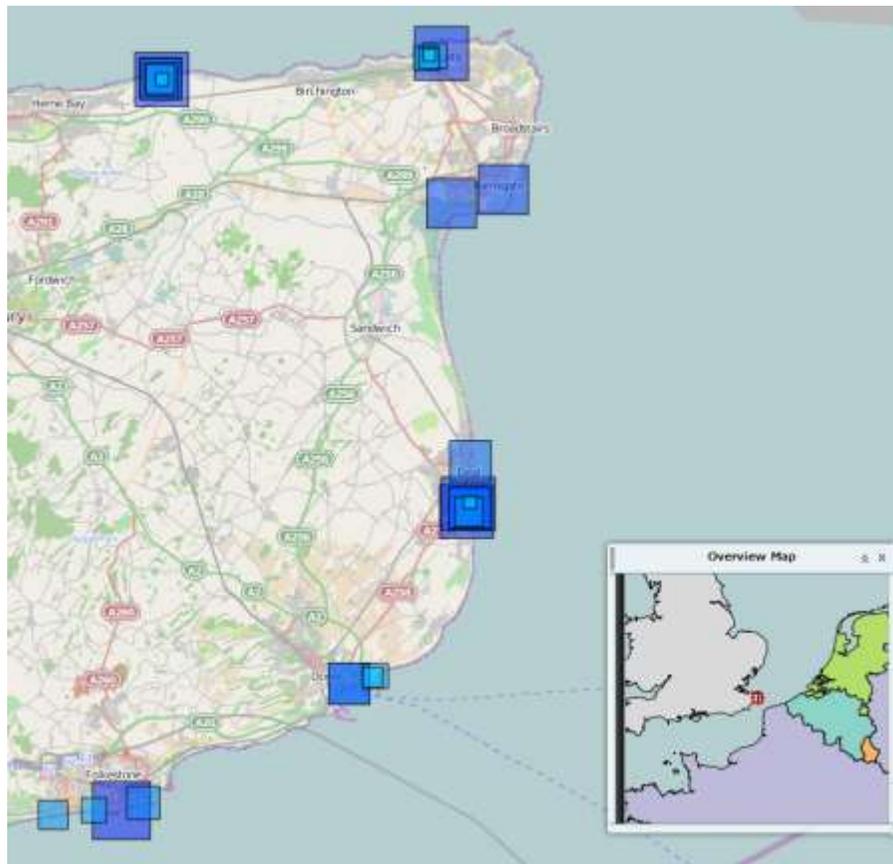
Figure 3B4. Map showing the distribution of artworks ranked within the Kent case study area.

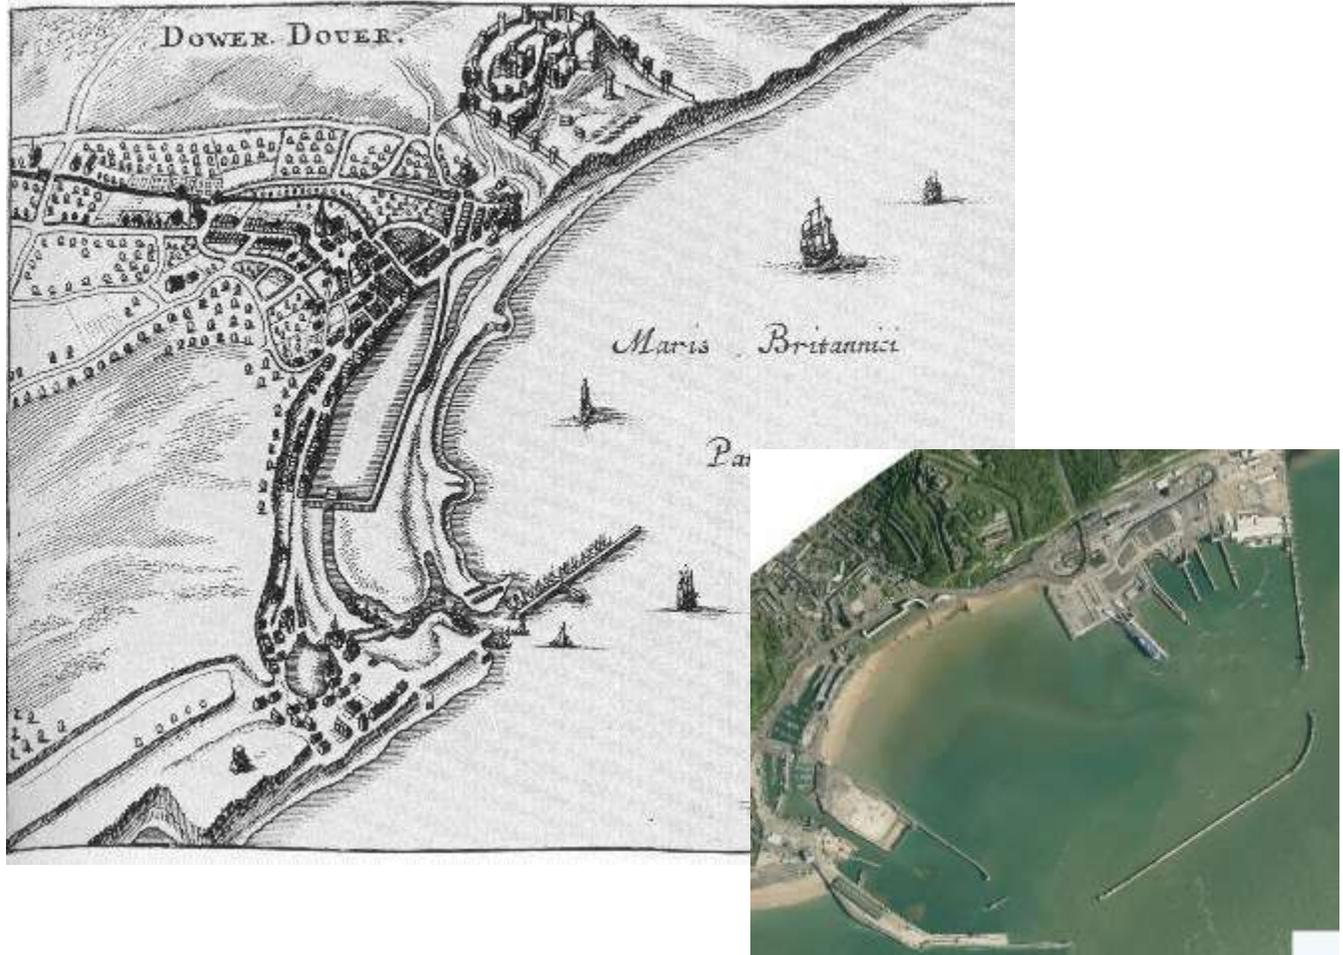
Figure 3B5. The image on the left is a map of Dover from 1661 (courtesy of genealogy.rootsweb.ancestry.com, the image on the right is an aerial photograph of Dover from 2013 (courtesy of the CCO).

Figure 3B5 shows a map of Dover by Rutger Hermannides in *Britannia Magna* from 1661. The map shows Dover Castle and the early harbour. Alongside the map is an aerial photograph of the area today.

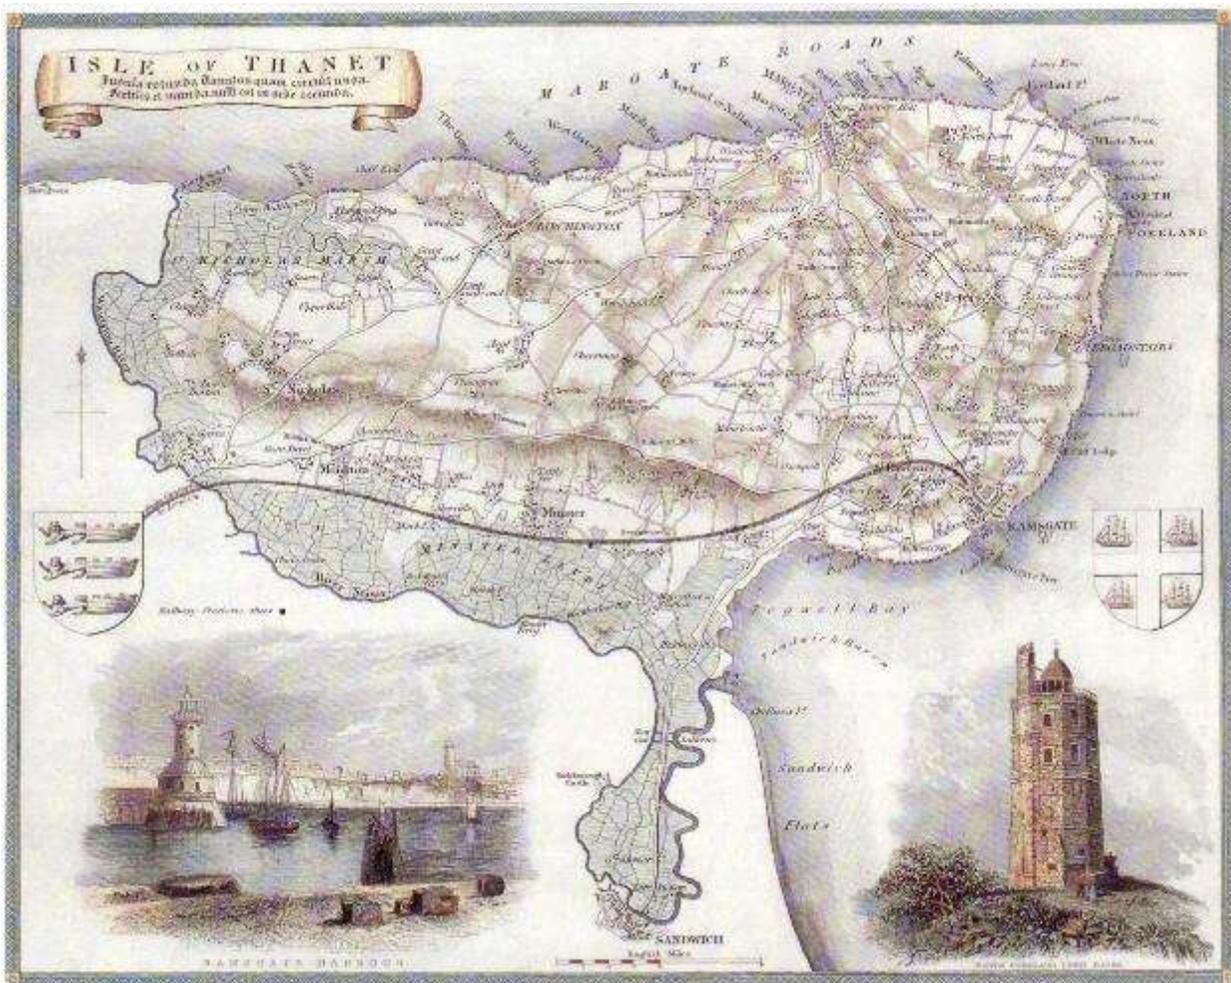
Figure 3B6. Map of the Isle of Thanet from 1836, from John Dower in Thomas Moule's *The English Counties Delineated*. (courtesy of genealogy.rootsweb.ancestry.com)

Figure 3B6 is a map of the Isle of Thanet from 1836, coastal structures such as piers and jetties are depicted, but there is little detail on the geology or geomorphology of the coastline. However, such maps often include illustrations of coastal sites, in this case there is a depiction of Ramsgate Harbour and North Portland light house. These images can also provide useful information on how the coast looked in this period.

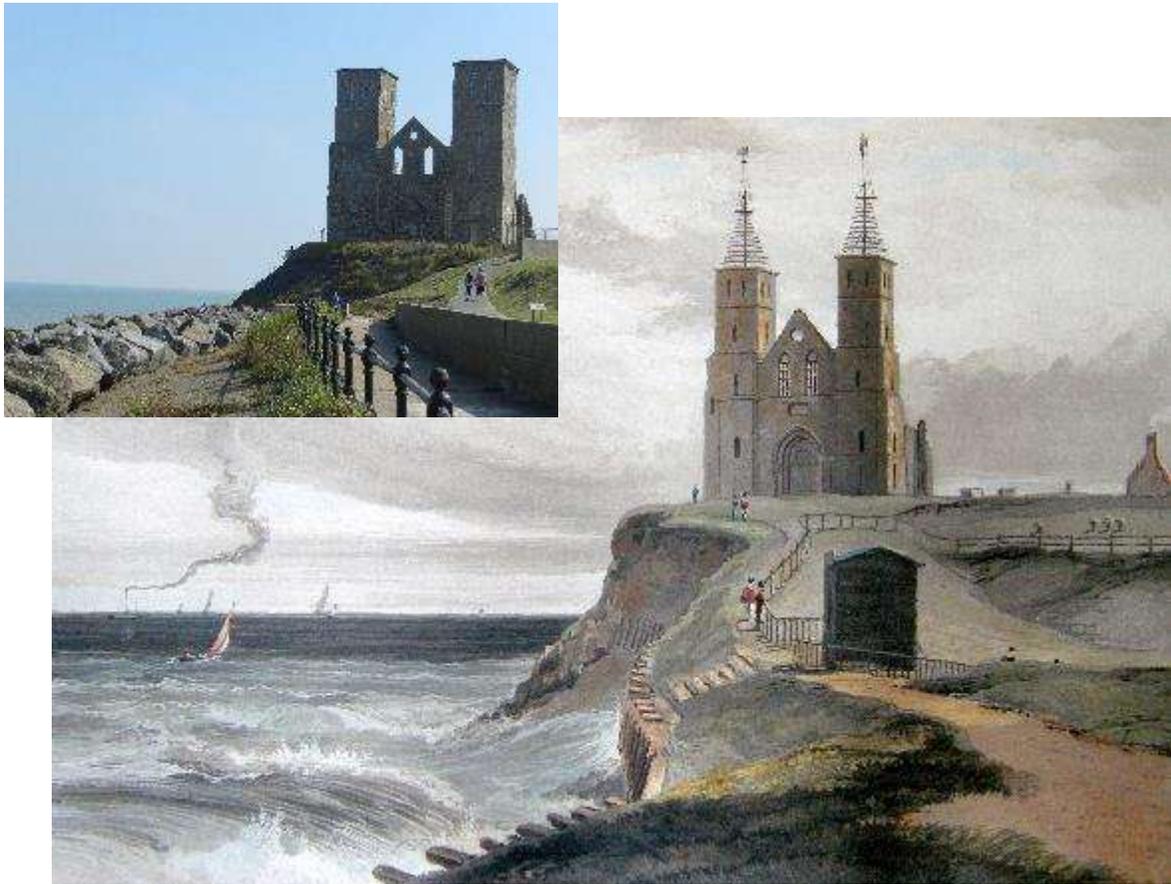
Figure 3B7. Reculver Church', North Kent coast by William Daniell, RA engraved in 1824. Some rudimentary coastal defences can be seen, which were helping to preserve this important landmark for navigation. A substantial rock revetment now protects the site.

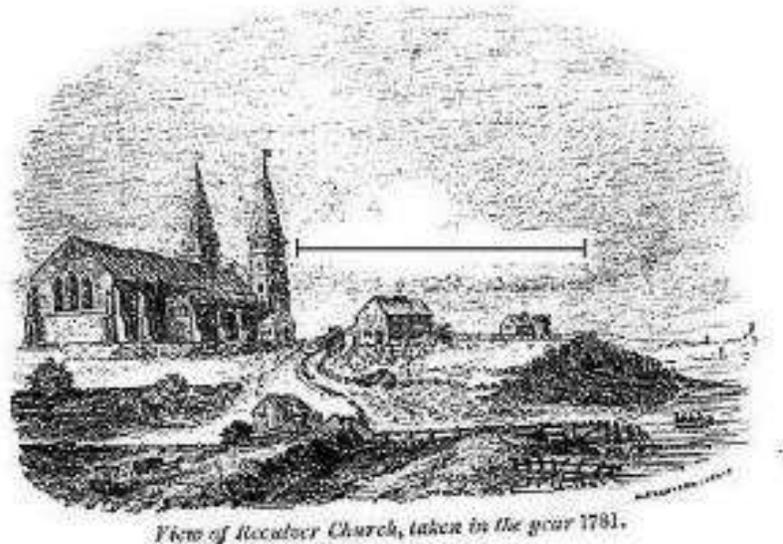
Figure 3B8. Charles Lyell cited the Roman shore fort of Regulbium (i.e. Reculver) as evidence of the scale and rate of marine erosion. In this view of 1781 Lyell observed that there had been a notable distance between the church and cliff line.

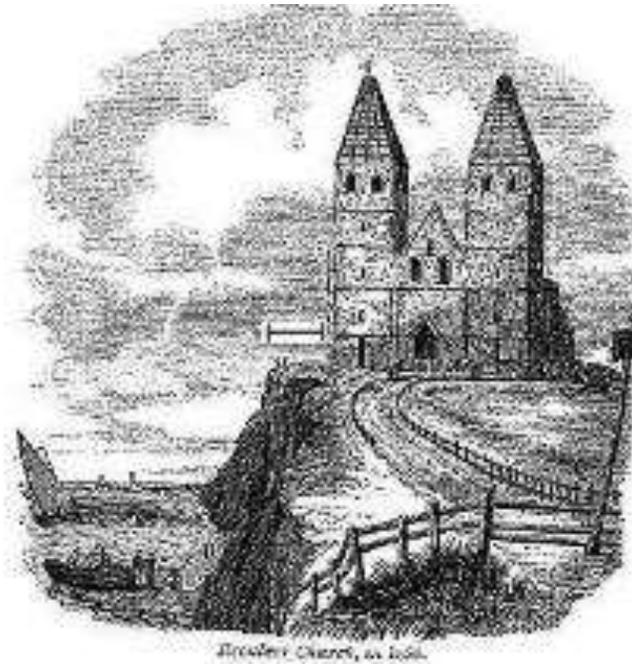
Figure 3B9. Lyell's view of 1834 shows the significant retreat of the shoreline since the previous engraving (above) was made in 1781.

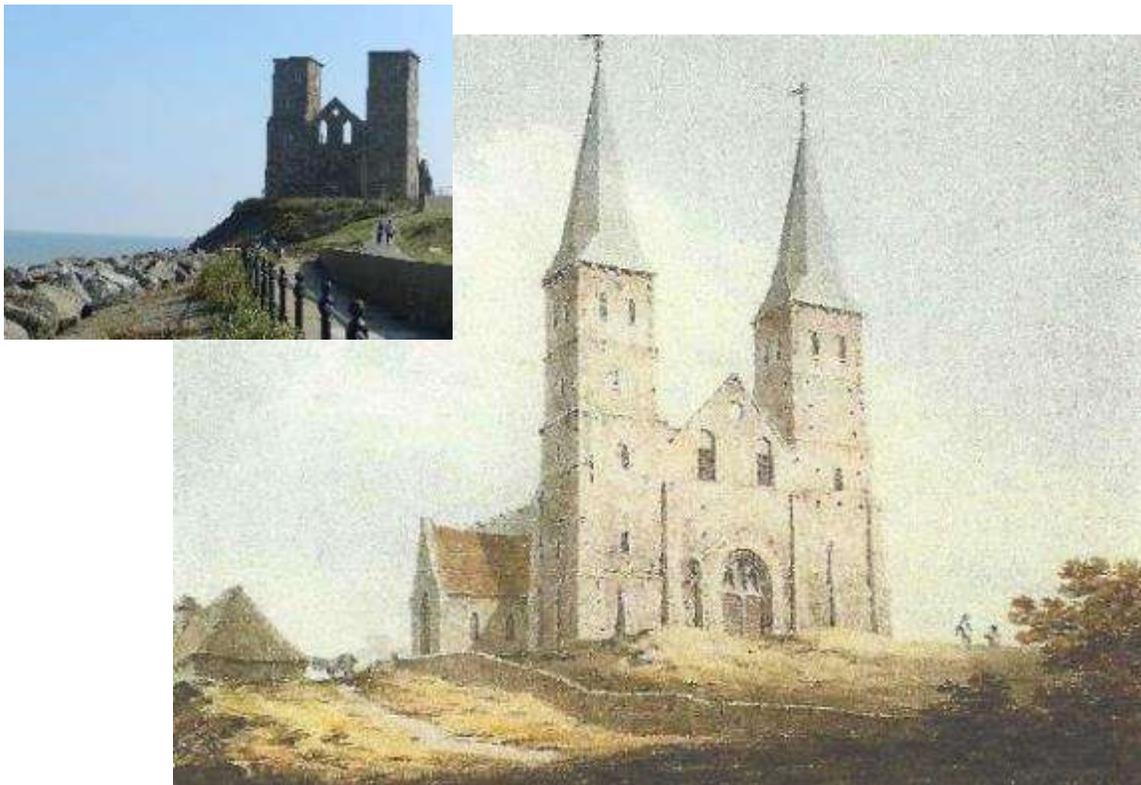
Figure 3B40. 'The Reculver', commonly called 'The Two Sisters' by James Malton, 1798. Malton's watercolour drawing shows a building existing between the seaward side of the church and the cliff edge. Image: Courtesy Bonham's. Private collection.

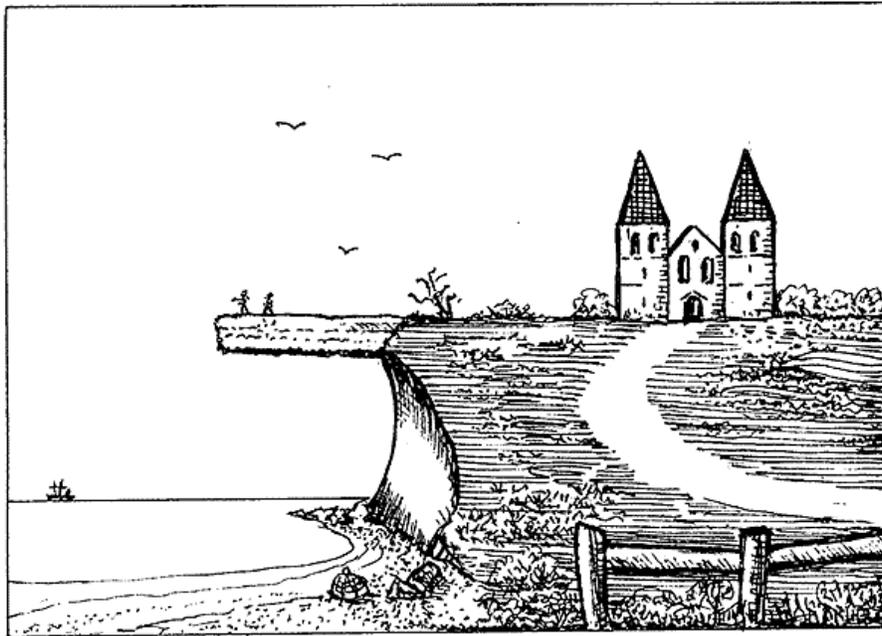
Figure 3B11. The Rev. J. Skinner recorded the wall of the Roman fort at Reculver in his diary around 1813 after the cliff had been drastically undercut by erosion. This diagrammatic drawing provides a simplistic summary of the erosion issue as he perceived it.

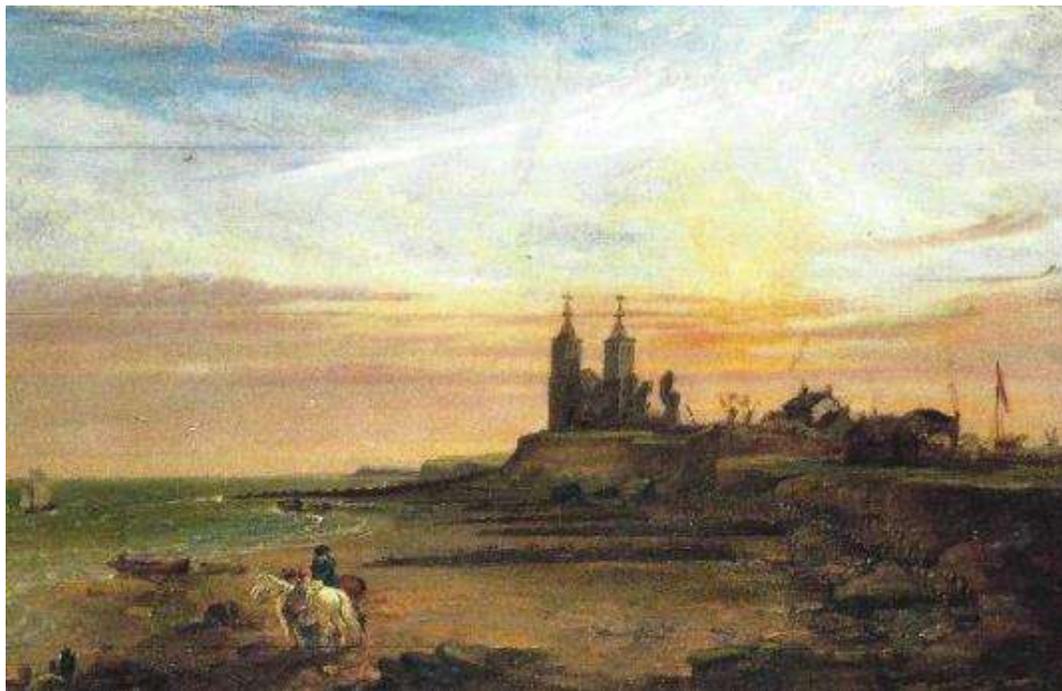
Figure 3B52. In this view of Reculver by James Ward painted in 1818 a range of coastal defences can be seen at the foot of the soft cliff line. Image courtesy of Canterbury City Museum & Art Galleries.

After Daniell's view of Reculver the next artwork in chronological succession was a painting by James Ward of 1818 entitled '*Reculver Church*' (Figure 3B12), which shows a view of the building dramatically located on the cliff edge taken from the west looking eastwards, whilst a further view by Stuart Westmacott (Figure 3B13), painted in 1851, shows the building from the east side looking west.

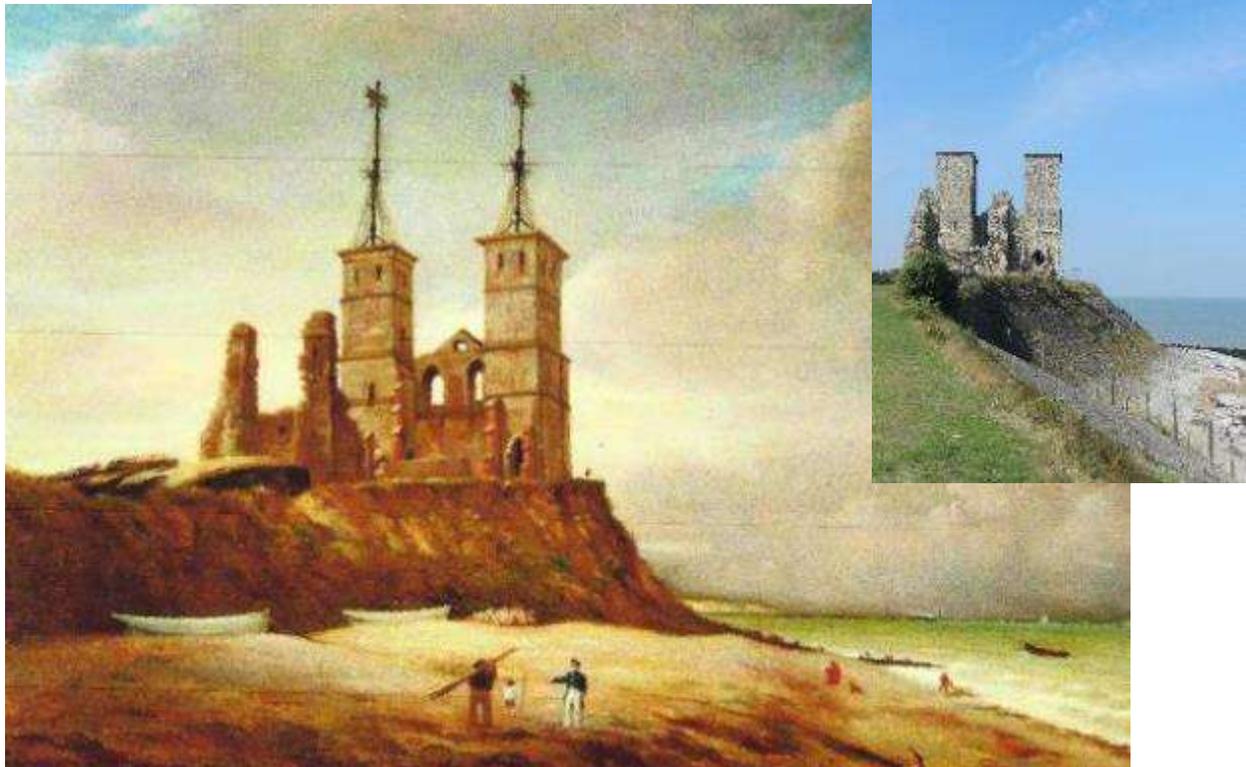
Figure 3B63. A further view of Reculver Church from the east side by Stewart Westmacott painted in 1851. Image courtesy of Canterbury City Museum & Art Galleries.

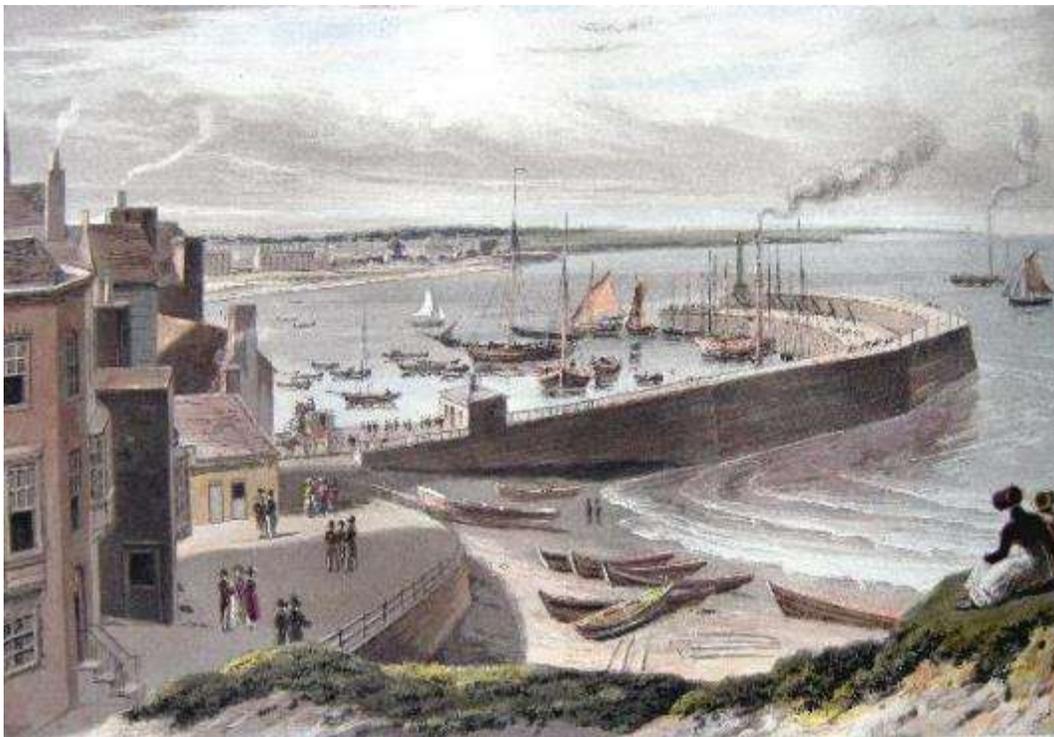
Figure 3B74. 'Margate' by William Daniell engraved in 1824. His view illustrates how artworks can depict not just physical change but also the history of coastal development and sometimes the modes of construction used.

This view is typical of the meticulous observation and eye for detail in William Daniell's aquatint engravings. It provides a wealth of information on the state of the coast in the emerging resort of Margate in the early part of the nineteenth century.

This view by Daniell was selected to illustrate the role that art can fulfil in terms of understanding not just physical changes on the coast but also the history of coastal development and construction. Not only are features such as harbour arms influential in terms of interruption of sediment transport but an understanding of their form can be particularly helpful to designers and coastal engineers who may wish to repair or replace these structures. It can be seen from Daniell's view (Figure 3B14) and from the present day view (Figure 3B15) that the harbour wall has stood the test of time and remains unaltered. Part of the former beach is now occupied by a dinghy park and the new Turner Contemporary Art Gallery can be seen on the left.

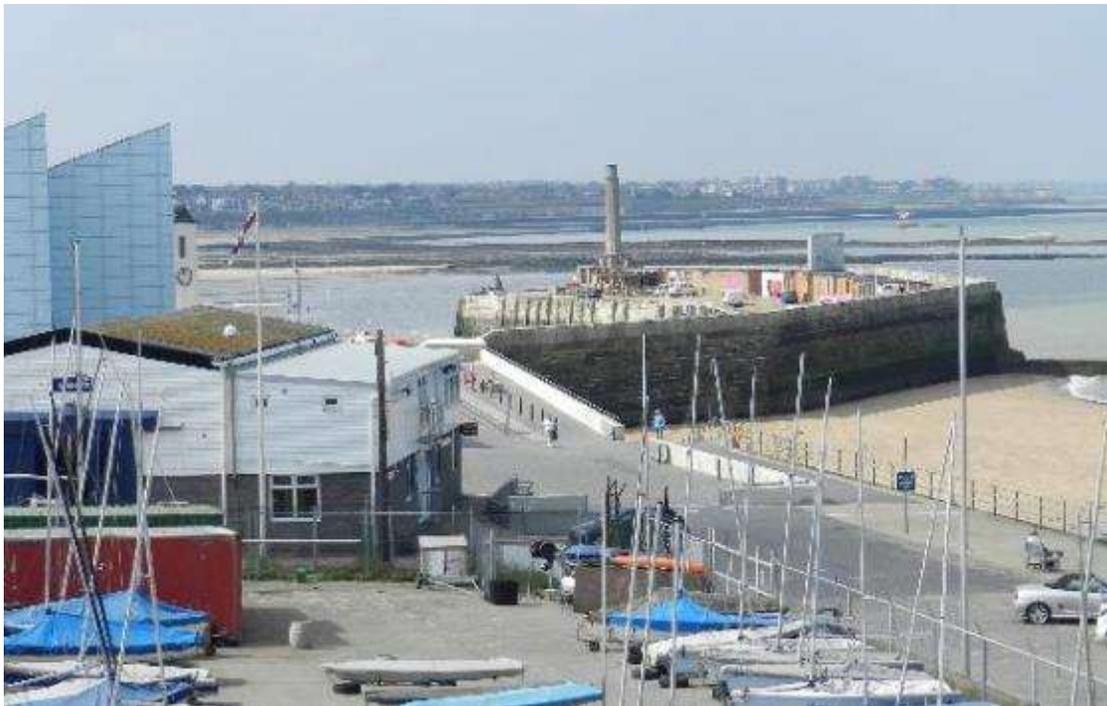
Figure 3B85. The present day view of Margate

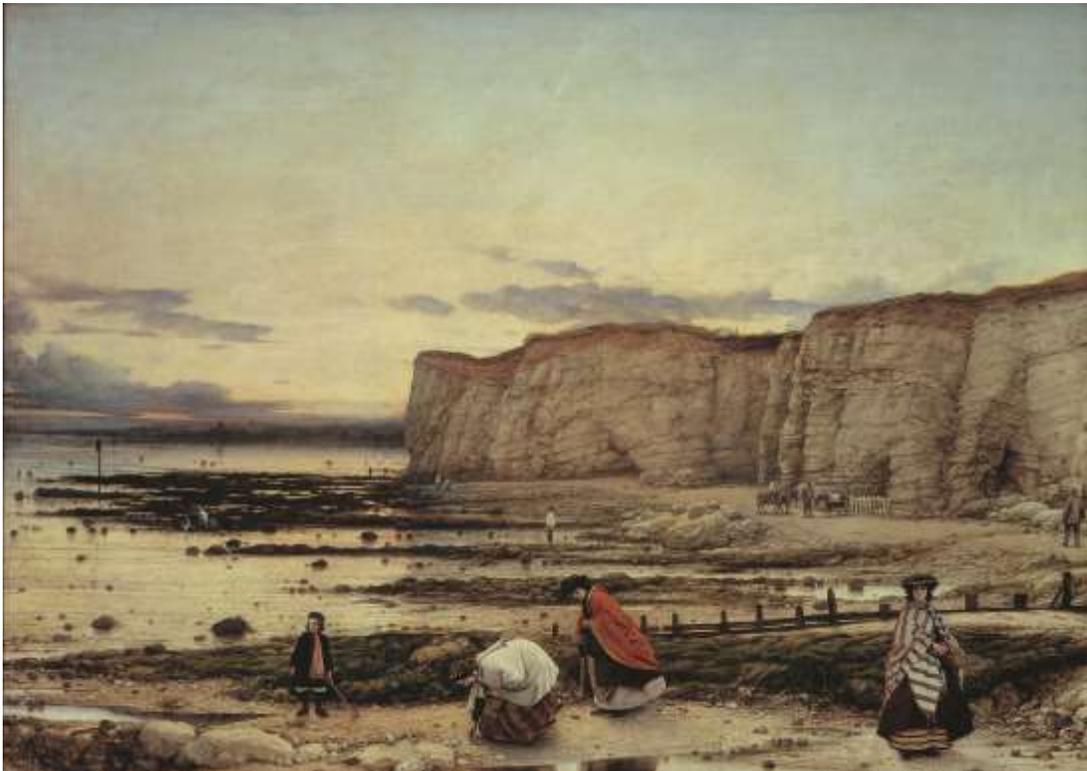
Figure 3B96. 'Pegwell Bay – Recollections of 5th October 1858' by William Dyce, RA demonstrates the precise detail that could be achieved by the Pre-Raphaelite artists. Dyce has achieved a depiction that has the appearance of a photograph. Courtesy of Tate Images 2014.

The painting by William Dyce is of particular interest on account of the extraordinary detail that has been achieved in this oil painting. In terms of the cliff-line the structure of the cliffs, including the jointing, is particularly well defined, as are the details of the caves running along the foot of the cliff. Along the foreshore one can see the wave-cut platform, which extends into the intertidal zone, and, in the foreground, details of a groyne forming a rudimentary coast protection structure. At the time the view was painted by Dyce it coincided with the emerging art of photography and many people thought this painting had been copied from a photograph, which was incorrect. However, it demonstrates the almost photographic detail that could be achieved through art by the followers of the Pre-Raphaelite ethos of capturing nature in its precise detail.

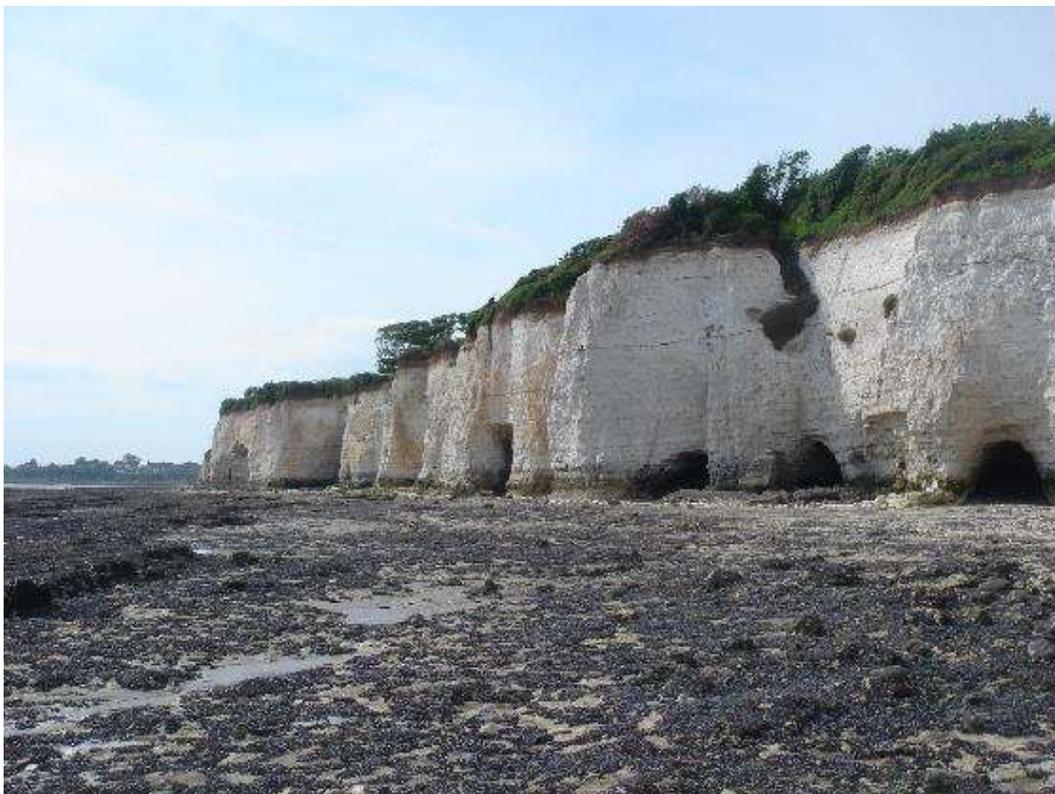
Figure 3B107. The chalk cliff frontage at Pegwell Bay today

Paintings of this kind can inform coastal risk management by providing a reliable comparison with the conditions to be found in later works of art, in photographs and when viewed at the present day. From the same spot estimates could be made of cliff retreat because it is possible to identify sections of cliff that may have fallen away as a result of undercutting of the toe of the cliff by the sea, and weathering over the last 160 years. It can, therefore, advise coastal engineers of the rate and scale of coastal change over a very long time span.

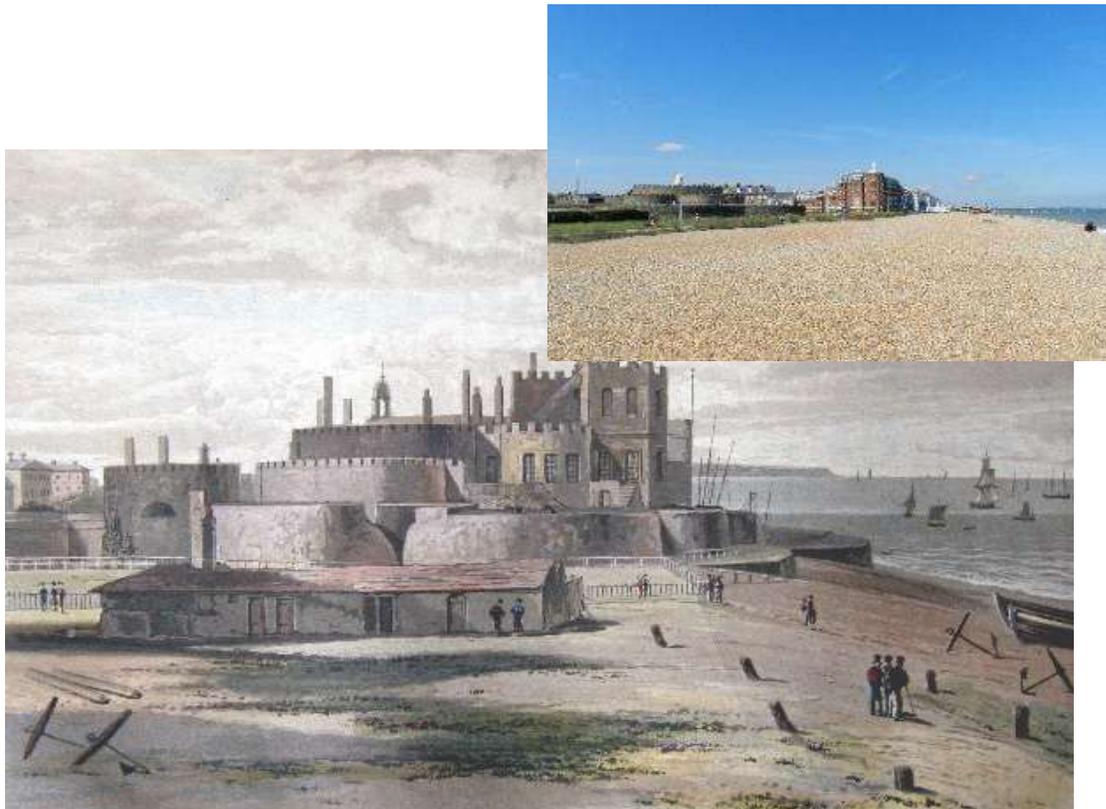
Figure 3B118. Deal Castle' by William Daniell, RA engraved in 1824. His fine draughtsmanship shows us the relationship between the structure and the shore at that time. A substantial beach now provides flood protection for this low-lying coastline. Private Collection.

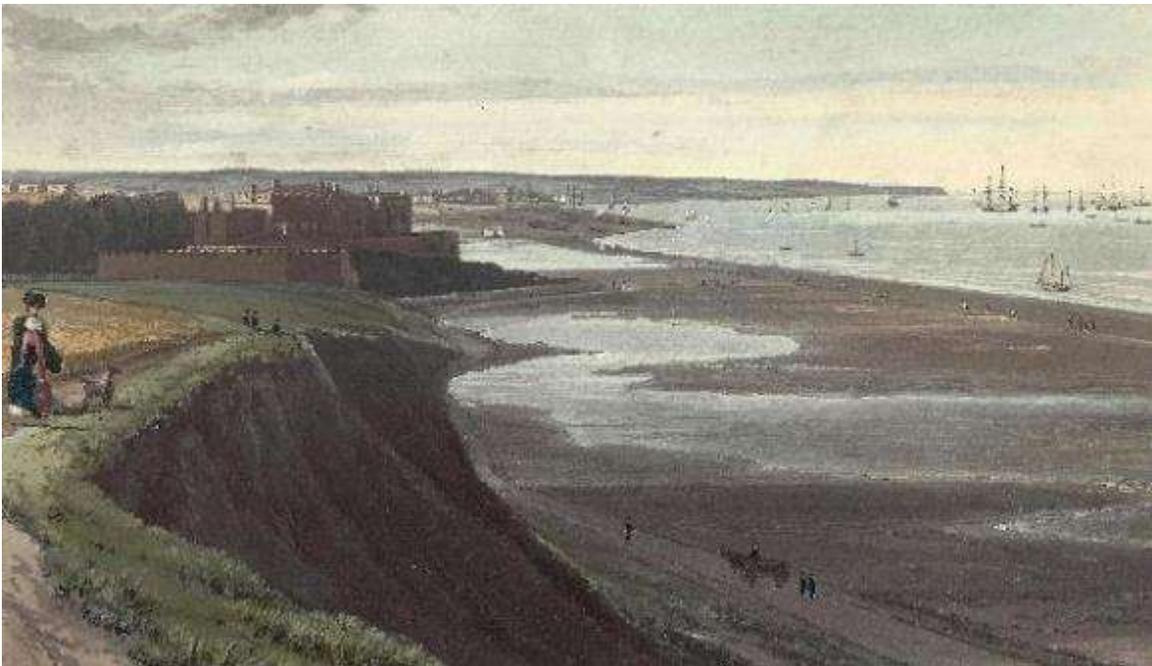
Figure 3B19. In his view of 'Walmer Castle' (1824) Daniell provides us with an extensive and detailed depiction of the shoreline and cliffs. The form of the beach at low water can be seen clearly. Some defences have been put in place around the frontage of the castle, which forms a hard point along this relatively soft coastline. Private Collection.

This view within Figure 3B19 shows the southern-most of three castles (the others are at Deal and Sandown) built in the 1530s by King Henry VIII. In the view by William Daniell (c.1824) the castle appears situated immediately above the beach. The beach appears to have taken on a barrel form with a crest, along which people can be seen walking, whereas, behind, shallow lagoons of water indicate where the sea has flooded through the barrier beach. A low wall appears to protect the foot of the slope below the castle from coastal erosion. The view describes, in a very precise way, the morphology of this part of the coastline, in particular the form of the cliffline and the extensive beach, looking northwards towards Deal.

The coloured aquatint engraving illustrates coastal conditions in the early nineteenth century and contrasts significantly with the present day situation where the beach appears much more stable, with the upper beach being vegetated. Whereas, in the view by Daniell, the Castle appears vulnerable to erosion and demanded the provision of a seawall, the present structure appears much more secure. The frontage could become increasingly vulnerable in the future as a result of coastal erosion promoted by rising sea levels, and so it is likely that the defences will be maintained for the foreseeable future, but may require replacement in the long term.

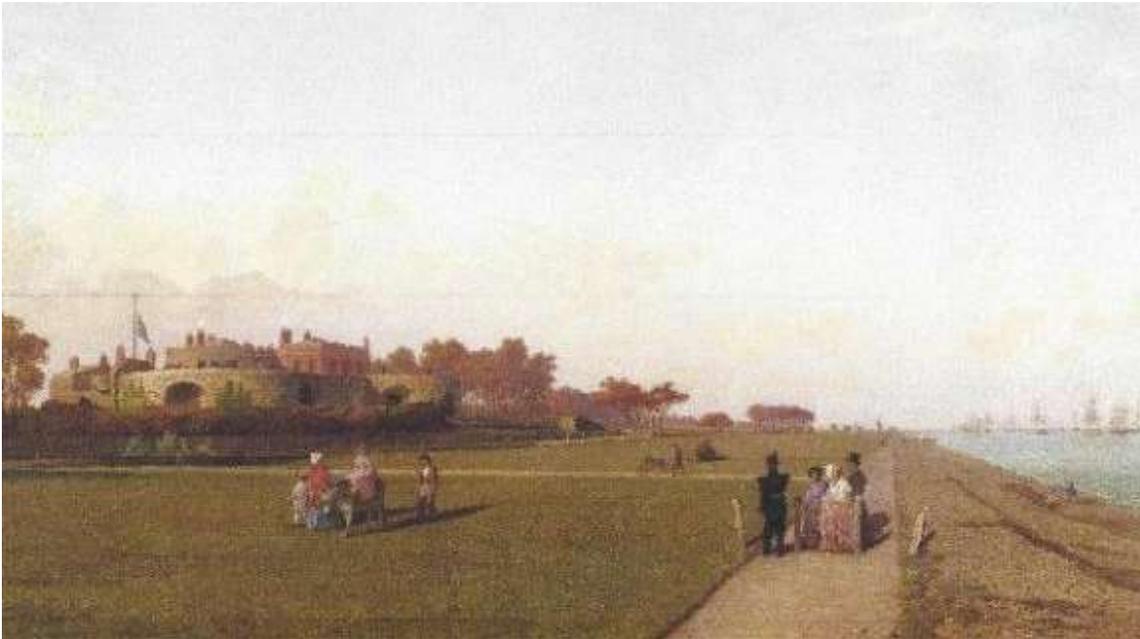
Figure 3B120. An oil painting by Henry Pether (c.1852) shows how the castle frontage has been extended seawards to create a lawns and a coastal path. Image courtesy of Woolley & Wallis, Salisbury.

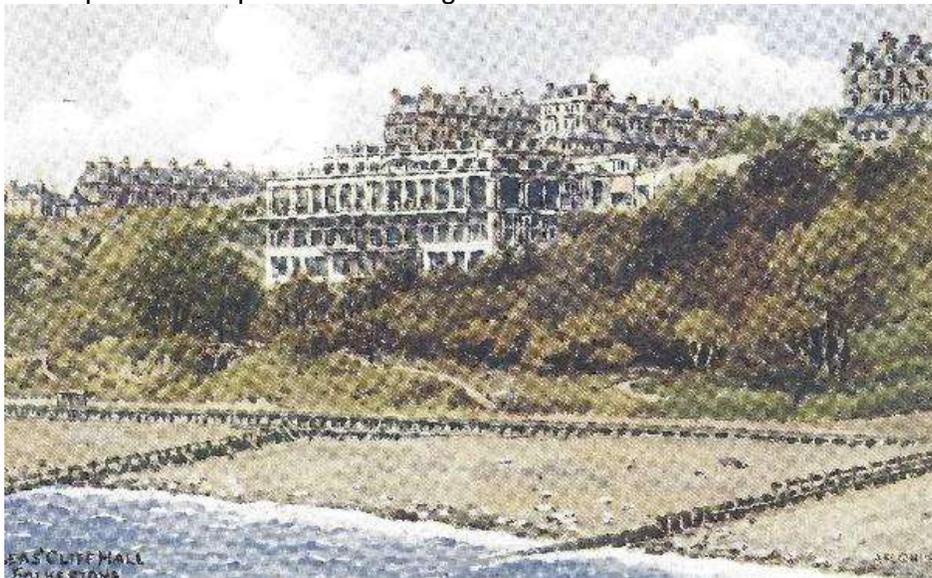
Figure 3B131. The Leas Cliff Hall in about 1900. The view was painted by the prolific coastal watercolourist, Alfred Robert Quinton. His view shows the wooded coastal slope and the beach levels against the coastal revetment and groynes (Image courtesy of J. Salmon of Sevenoaks).

The artwork can be used to demonstrate changes in the form and volume of the beach over time. Bearing in mind that along much of the coastline of England, no formal monitoring systems existed until some 20 years ago, it is possible to use images such as this to gain a longer term perspective on beach change and to gain insight of past conditions which may assist the selection of coast protection options for frontages in the future.

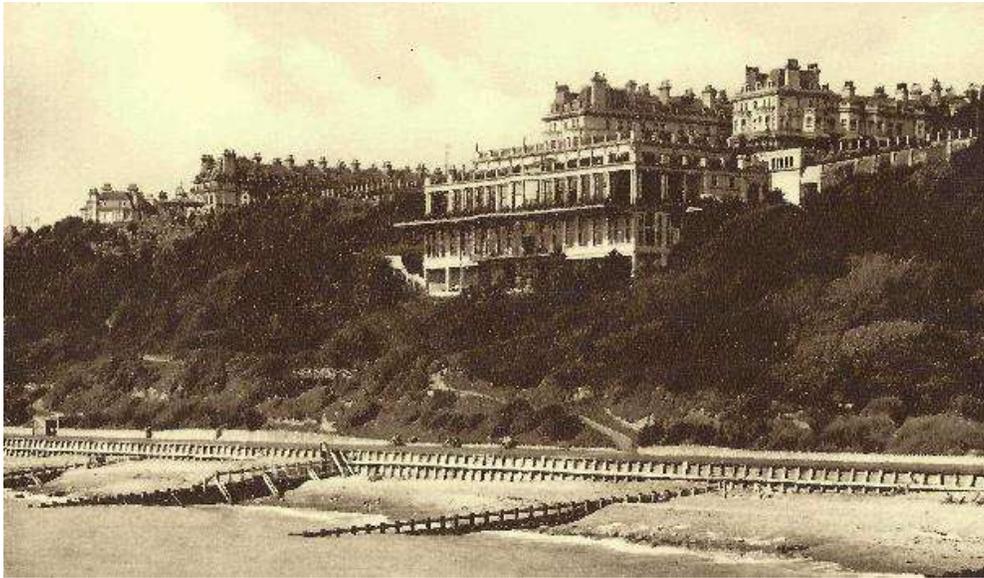
Figure 3B142. Photograph taken in 1900 and compares closely with Quinton's watercolour (above); the beach appears lower and steeper in this view. Private Collection.

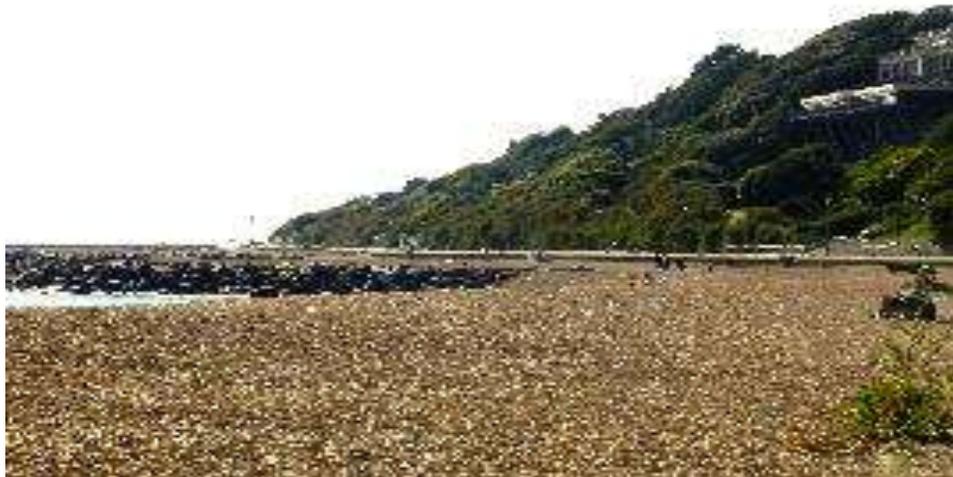
Figure 3B153. The present day view, shows the coastal slope, which has faced some instability problems and the upgraded coastal defences including rock groyne.

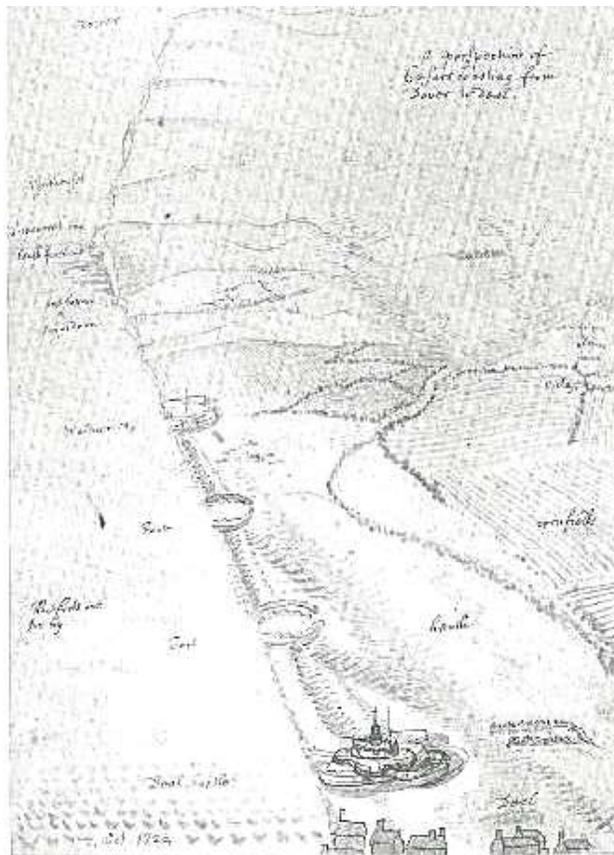
Figure 3B164. William Stukeley's 'bird's eye view' of the southern forts, showing Deal Castle (foreground) and Walmer Castle. 1725.

The three forts were sketched by William Stukeley in 1725 (Figure 3B17). Stukeley produced two views of the northern flank of the defences, and a bird's eye view of the southern side. The sketches are revealing in that they show the water running right up to all three forts and against the earthen defences. The beach would appear to be right against the outer moat wall and may have even breached Walmer's moat (Saunders, 1989: 39). This is supported by a 1725 War Department plan of Walmer Castle that shows the moat wall as incomplete on the coastal side of the fort and that the mean high water mark is only 10 to 11 metres from the two eastern bastions. An annotation suggests that the loopholes on this side have been walled up to prevent the sea from flooding through them.

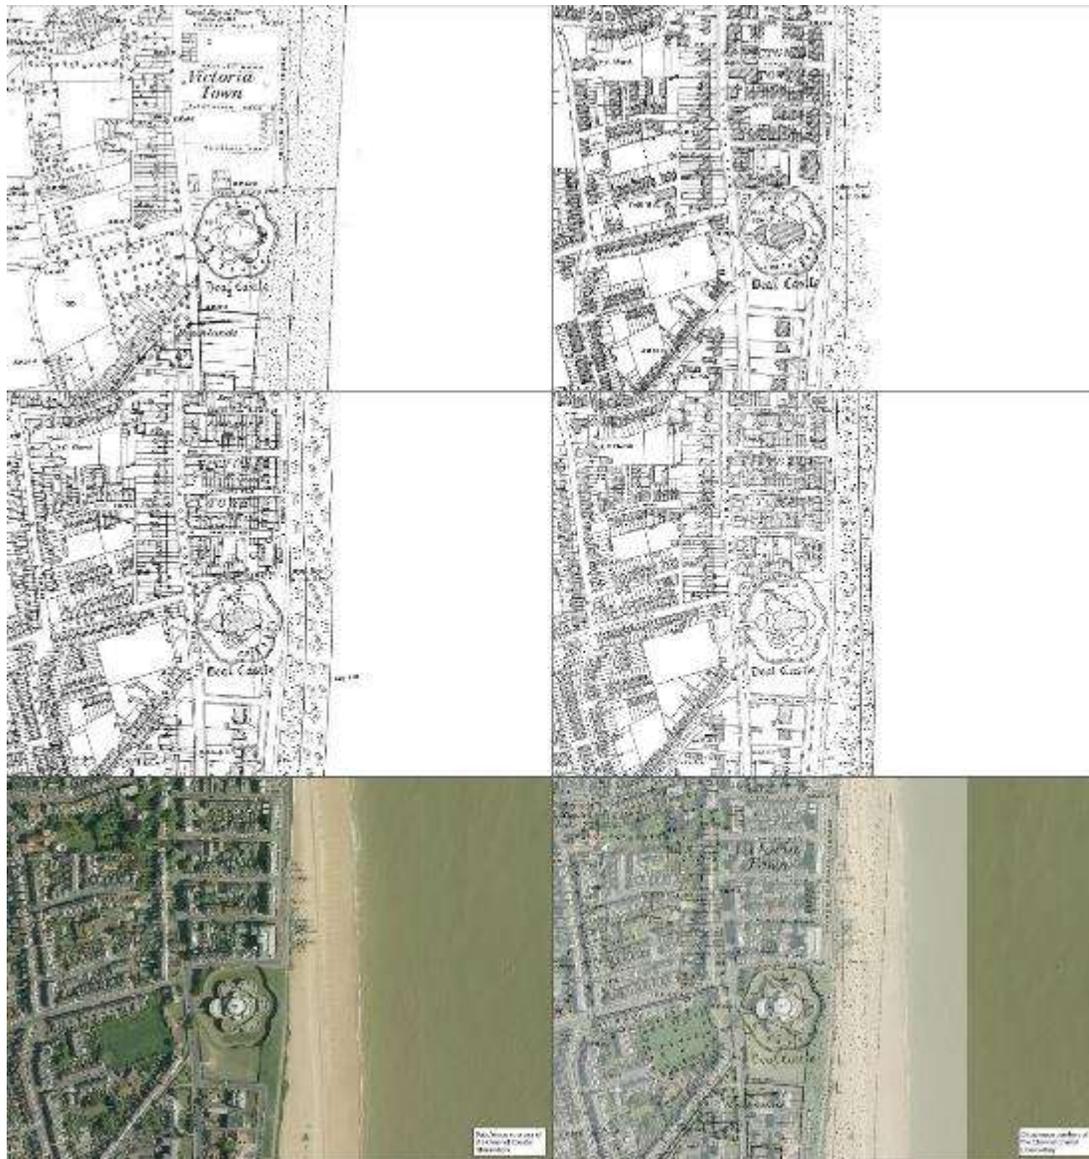
Figure 3B197. Ordnance Survey maps of Deal Castle. From left to right, top to bottom: 1st edition (1872), 2nd edition (1898), 3rd edition (1906), 4th edition (1938), modern aerial imagery (2014) and merge of the 1st edition map with modern aerial imagery, showing the full extent of coastal change since 1872

At Deal the fort was built to a similar standard at Walmer, but had six bastions instead of four. A 17th century engraving by Wenceslaus Hollar shows the moat as dry, but the proximity to the coast is notable. Daniell's Deal Castle engraving of 1824 appears to show the shoreline creeping closer to the fort and even beginning to undermine the moat's external wall. Again, the OS County Series maps chart a slow reclamation of the shore and the mean high water mark moves from 20m away from the moat in 1872 to 45m in 1938.

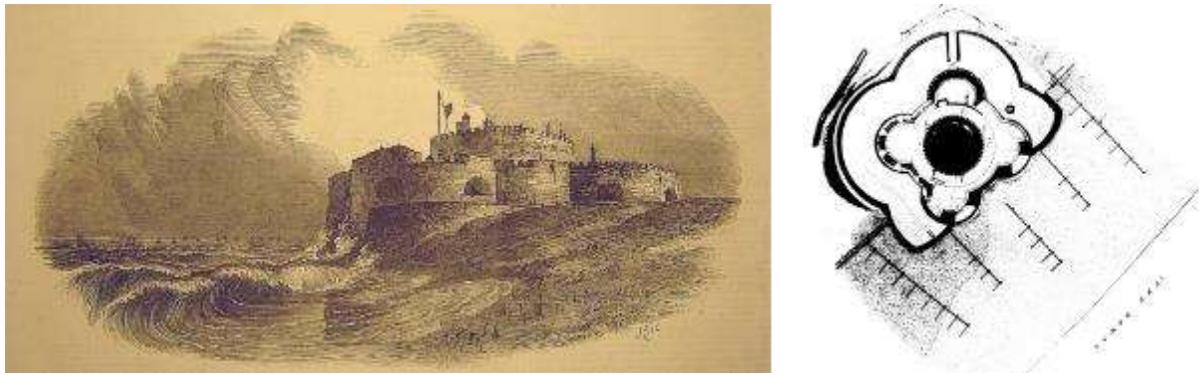
Figure 3B208. Two views of Sandown Castle; a plate from the *London Illustrated News*, 1853 and; a *Royal Engineer Map* from 1860-1865.

Sandown, the northernmost of the three forts, has suffered the most from coastal erosion. Although evidently in use up until the 19th century, the moat was apparently breached at the end of the 18th century and a Victorian plan from 1860-1865 shows the fort itself half sat on the beach; the dry moat has been totally lost on the east side and the two eastern bastions face directly onto the beach. An attempt has been made to close the remaining moat off from the sea and there are a number of groynes on the beach, presumably to try and stabilise the shoreline. This condition is reflected in an 1853 print from the Illustrated London News that shows the sea lapping against the eastern bastions (Figure 3B28).
