CASE STUDY 3B – KENT, UK

Case Study Area: Kent, UK

This case study report is part of the technical report on the Arch-Manche project, which quantifies the value of under-used coastal indicators that can be applied as tools to inform long term patterns of coastal change. In addition, it provides instruments to communicate past change effectively, model areas under threat and interpret progressive coastal trends.

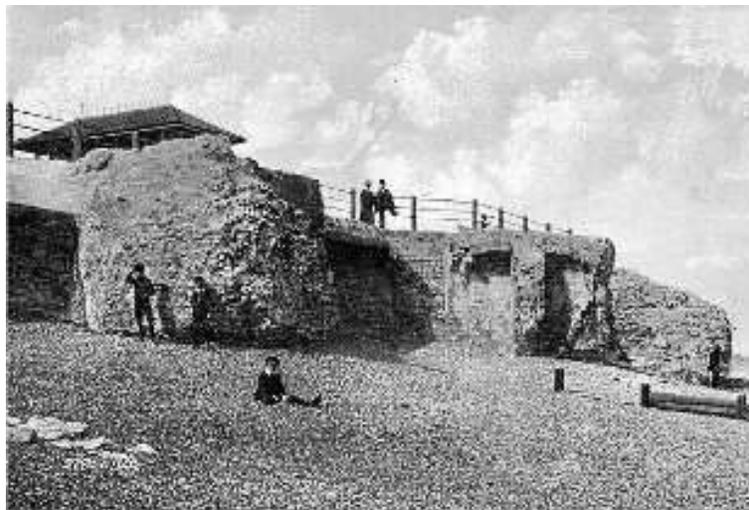
Figure 3B29. Sandown castle seen from the beach in the early 1900's.

By 1872 the condition is much worse; the OS County Series first edition map shows the castle to be largely destroyed by the sea. Artwork from the *Illustrated London News* on 18th November 1882 shows the fort at the time of its demolition (the War department having decided that nothing could be done to sustain it); the fort's central keep and bastions are largely ruined. All trace of the fort bar the foundations of the two westernmost bastions has been removed by the second edition map of 1898.
