CASE STUDY 3C – HASTINGS, UK

Case study area: Hastings, UK.

Main geomorphological types: Soft cliffs, sand and shingle beaches.

Main coastal change processes: Cliff erosion and instability, beach change.

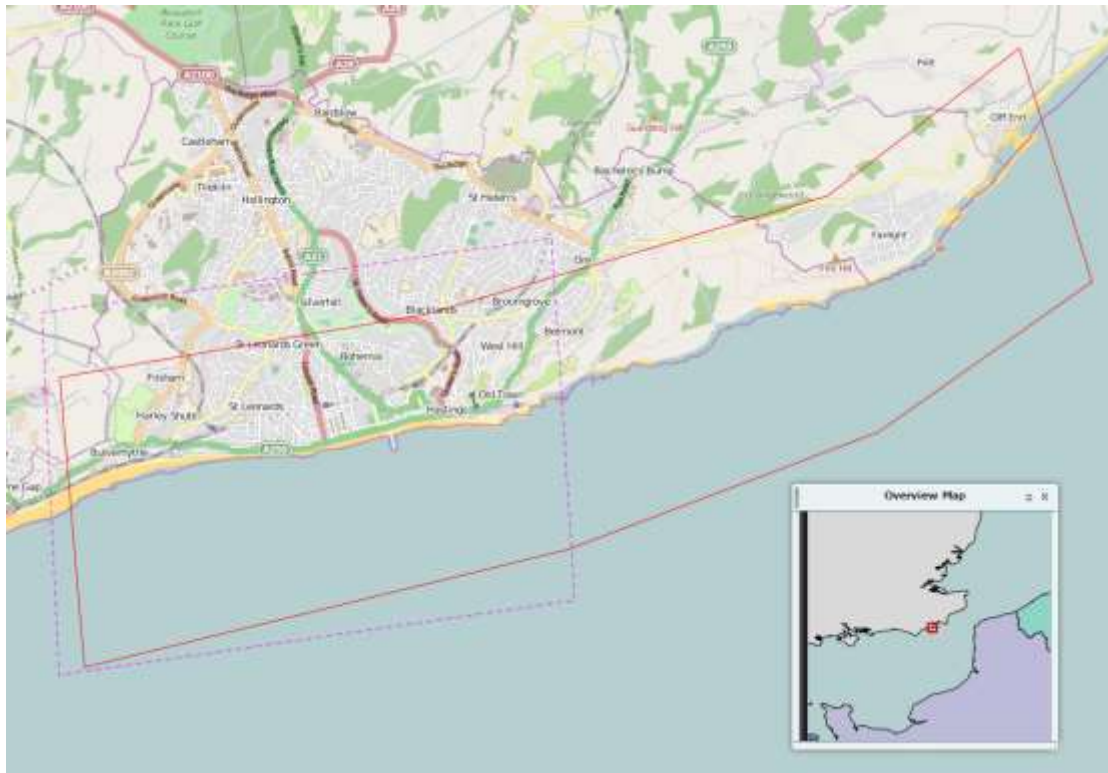
Figure 3C1. Map of the Hastings Study Areas. The dotted line is the extent of the archaeology area and the red square is the extent of the art area.

Within the Hastings area the archaeological and palaeoenvironmental resource and the available art resource have been researched, ranked and analysed. The extents of the detailed study areas are shown in Figure 3C1 below. The area considered for archaeology and palaeoenvironment has been selected to provide a representative range of types of evidence across a range of periods spanning from Palaeolithic through to more recent coastal heritage. The art, photograph and map case study area encompasses a broader stretch of the coastline to reflect the various coastal morphologies and features which have been depicted over time.

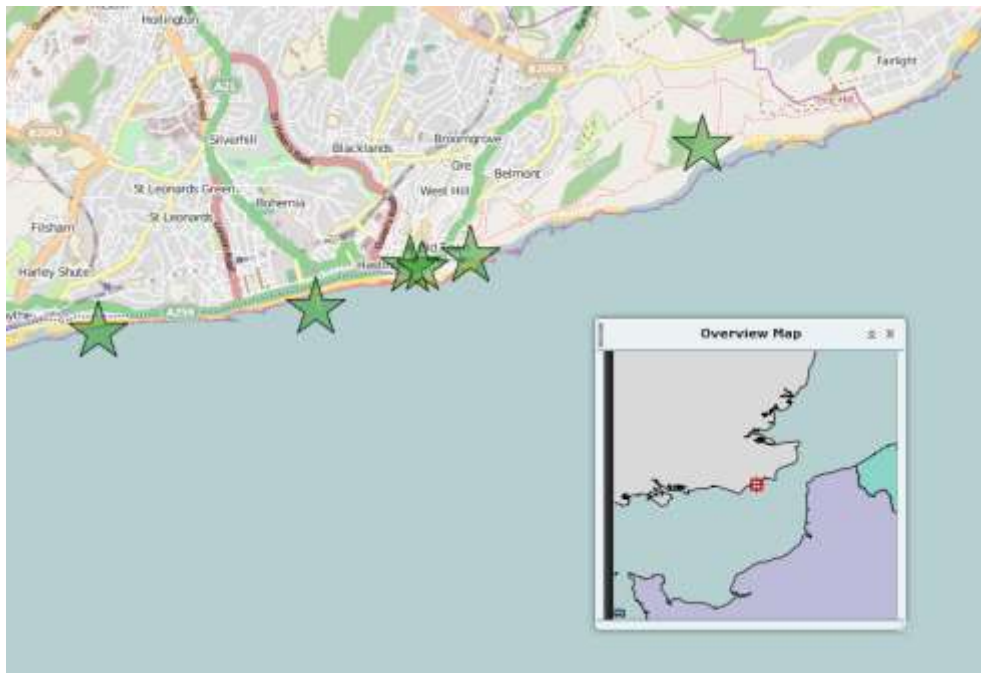
Figure 3C4. Location of historic photos assessed within the Hastings study area

The focus of the Hastings case study area is on the archaeological/palaeoenvironmental data and historic paintings. However, in order to demonstrate the potential of historic photos a selection of six images were assessed, the results of the ranking are presented below, the ranking methodology is outlined in [Section 2.2](#). Hundreds of historic images exist for this stretch of coastline, it should be noted that this study is not intended to be exhaustive, it simply aims to highlight the potential for historic photos to provide information on coastal change. A brief search of resources available online was carried out, although further research online, in museums and galleries, as well as private collections has the potential to provide many more.

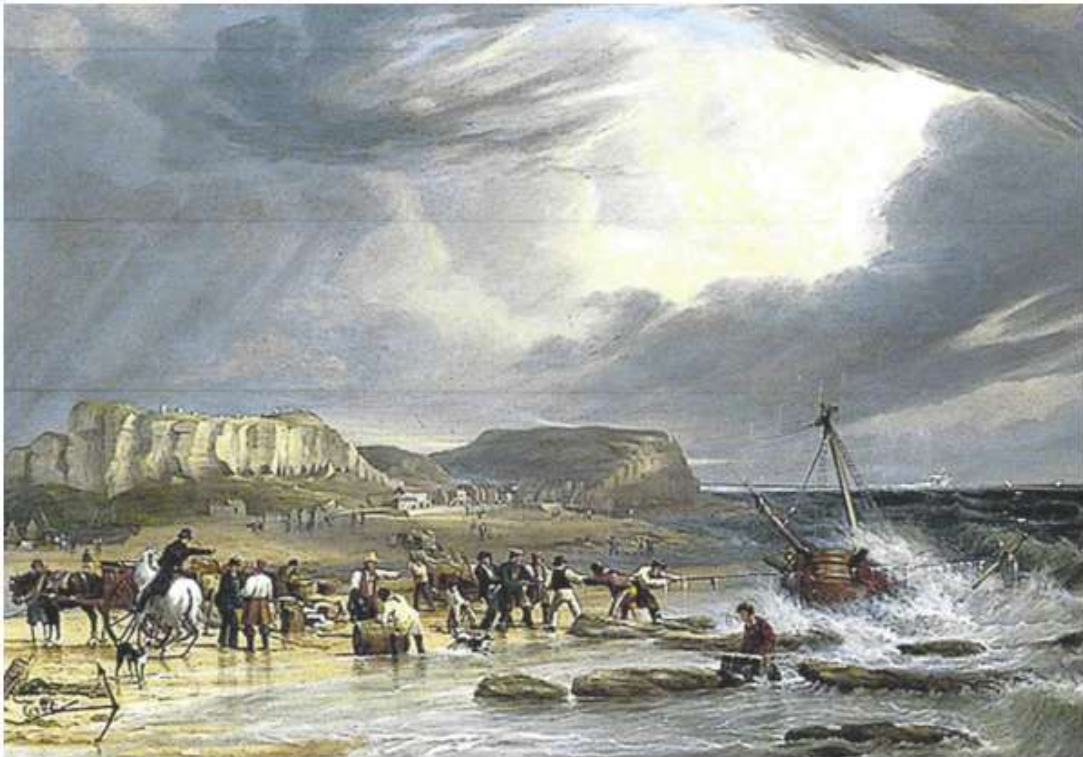
Figure 3C6. 'Rescue at Hastings' by William George Moss, 1814. This oil painting shows the Hastings frontage from Low Water Mark, looking east along the extensive beach towards the town, and the high sandstone cliffline beyond. Image courtesy of Hastings Museum & Art Gallery.

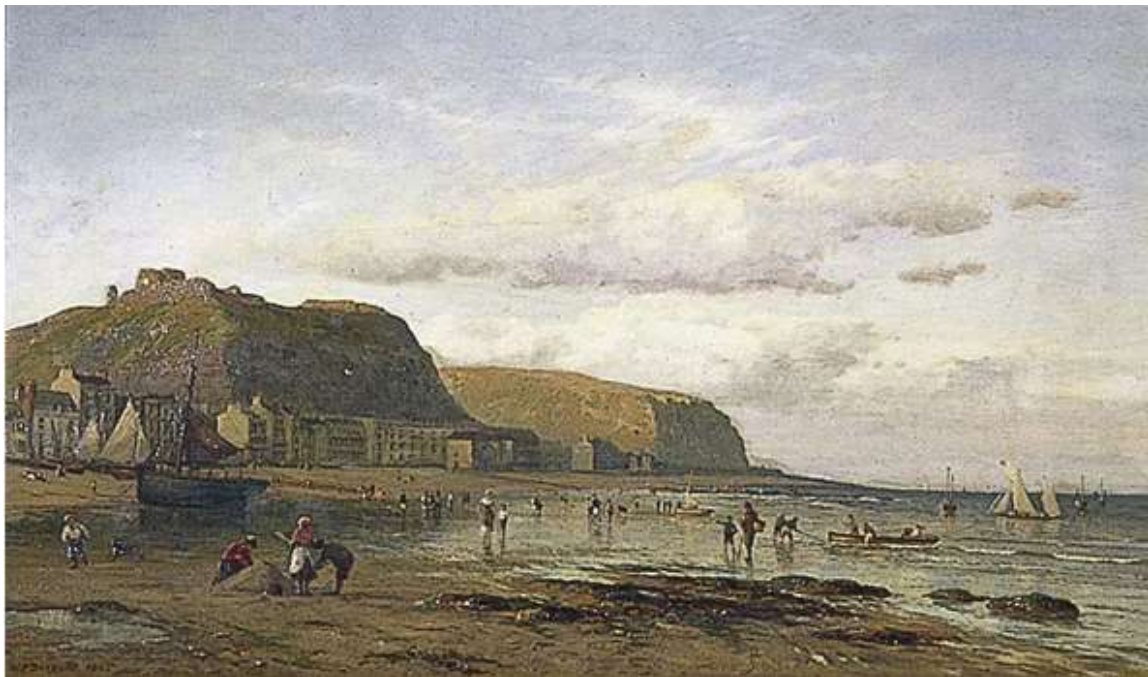
Figure 3C7. An oil by the prolific Hastings artist, William Henry Burrow, dated 1885. The relatively gentle sloping foreshore can be observed. Hastings Castle on the top of the cliffs overlooking the expanding seaside resort. Image courtesy of Hastings Museum and Art Gallery

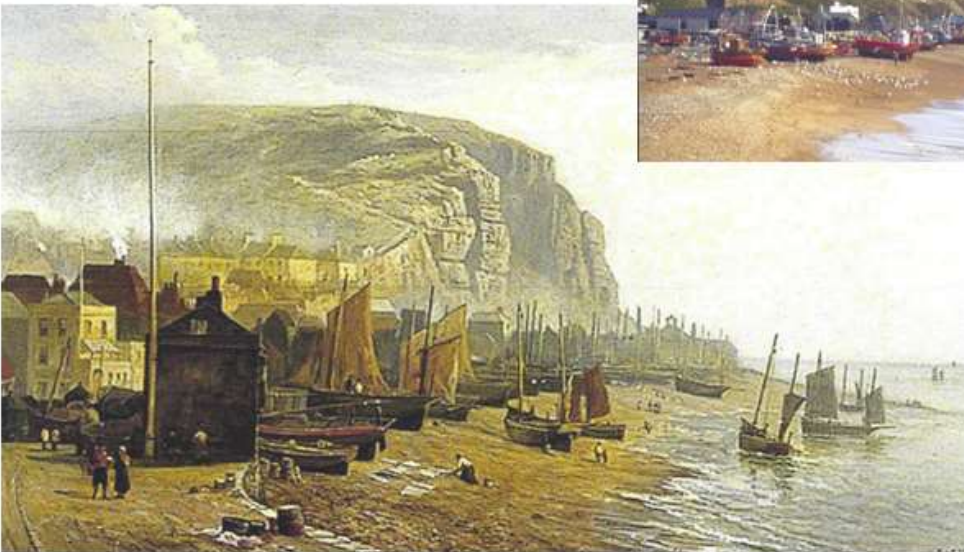
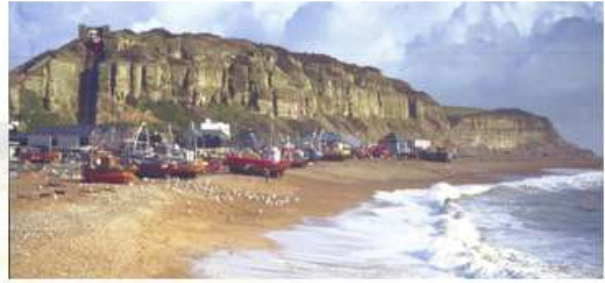
Figure 3C8. A further oil by W. H. Borrow, dated 1879, showing the steeper beach at the eastern end of the Hastings frontage; this is also reflected in the present day view. Image courtesy of Hastings Museum and Art Gallery

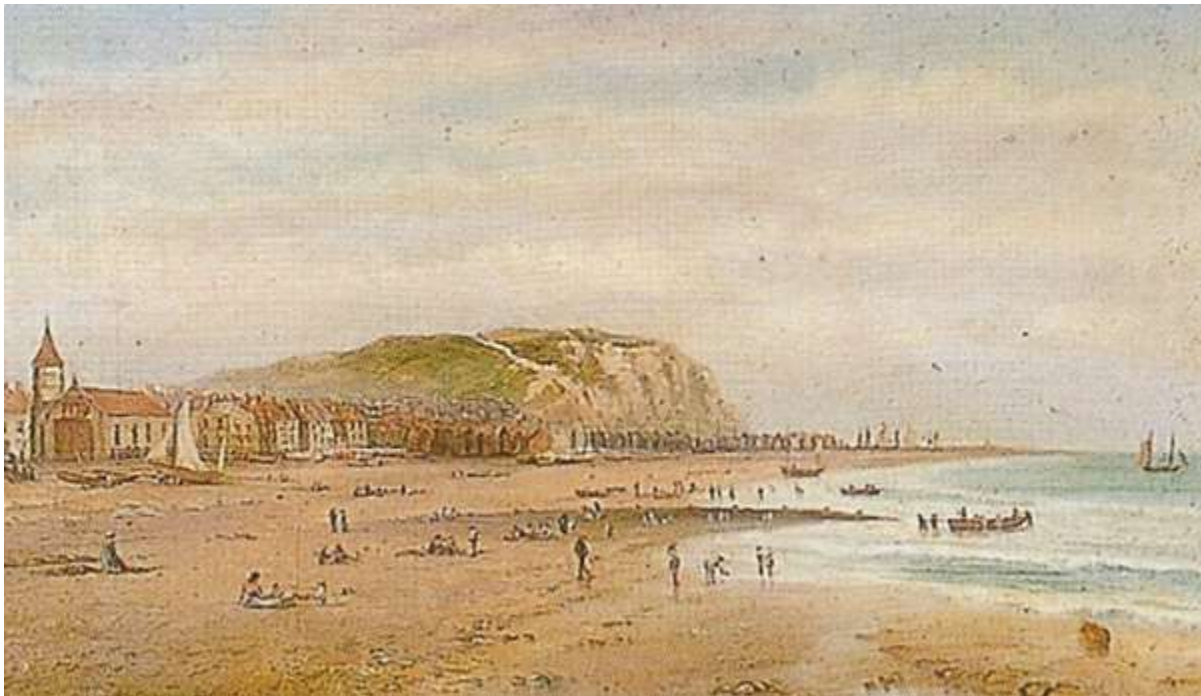
Figure 3C9. An oil by Edwin Hayes entitled 'Old Hastings', 1880, taken from Low Water Mark, showing the considerable expanse of beach at that time. Image courtesy of Hastings Museum and Art Gallery

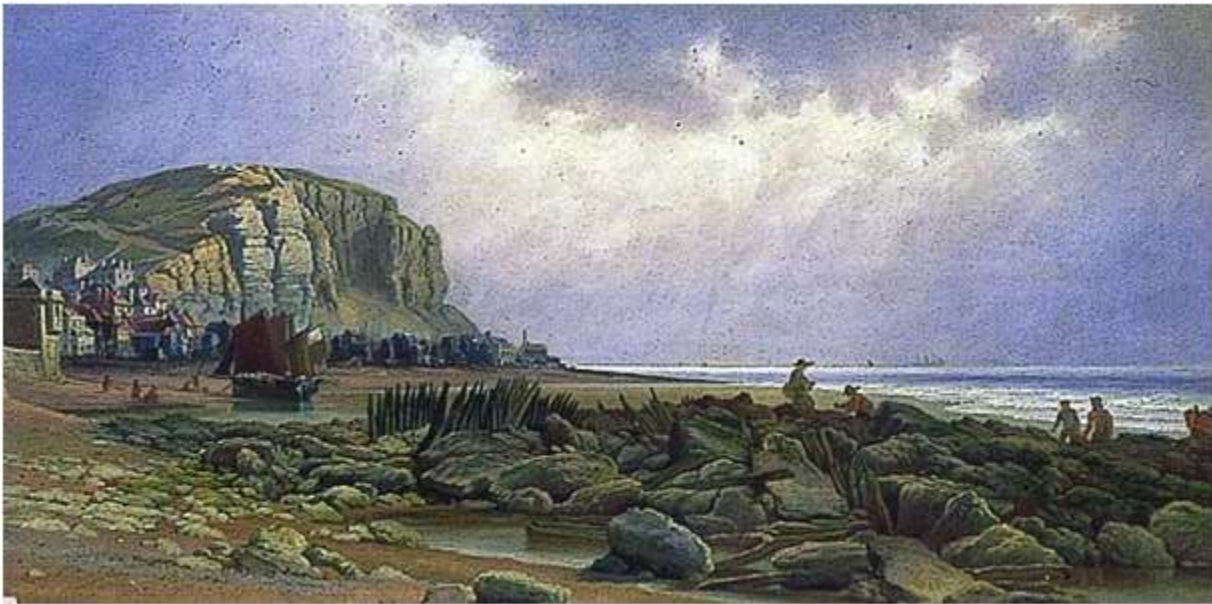
Figure 3C10. 'Remains of the Elizabethan Harbour at Hastings' by Charles A. Graves, 1901. This view shows the timber relics of the harbour. Beyond is the fishing village and behind it the jointing and mechanisms of failure of the rugged sandstone cliffs are particularly well painted, Image courtesy Hastings Museum and Art Gallery

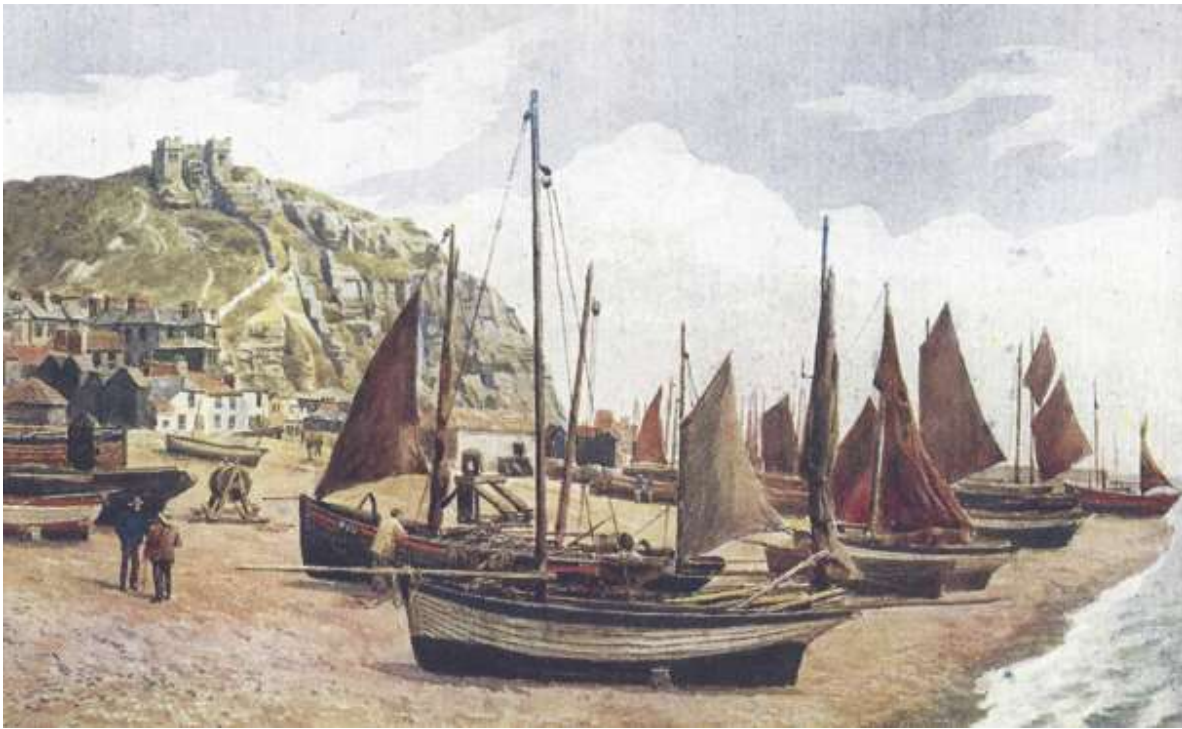
Figure 3C12. A detailed watercolour of the eastern end of Hastings beach in about 1920 by Alfred Robert Quinton. The boats are beached at the waterline below a change in the profile of the shore, which is still present today. The castle is visible on the cliffs behind. Image Courtesy J.Salmon Ltd

beach levels is indicated in the watercolour of the fishing fleet by Alfred Robert Quinton (Figure 3C122)

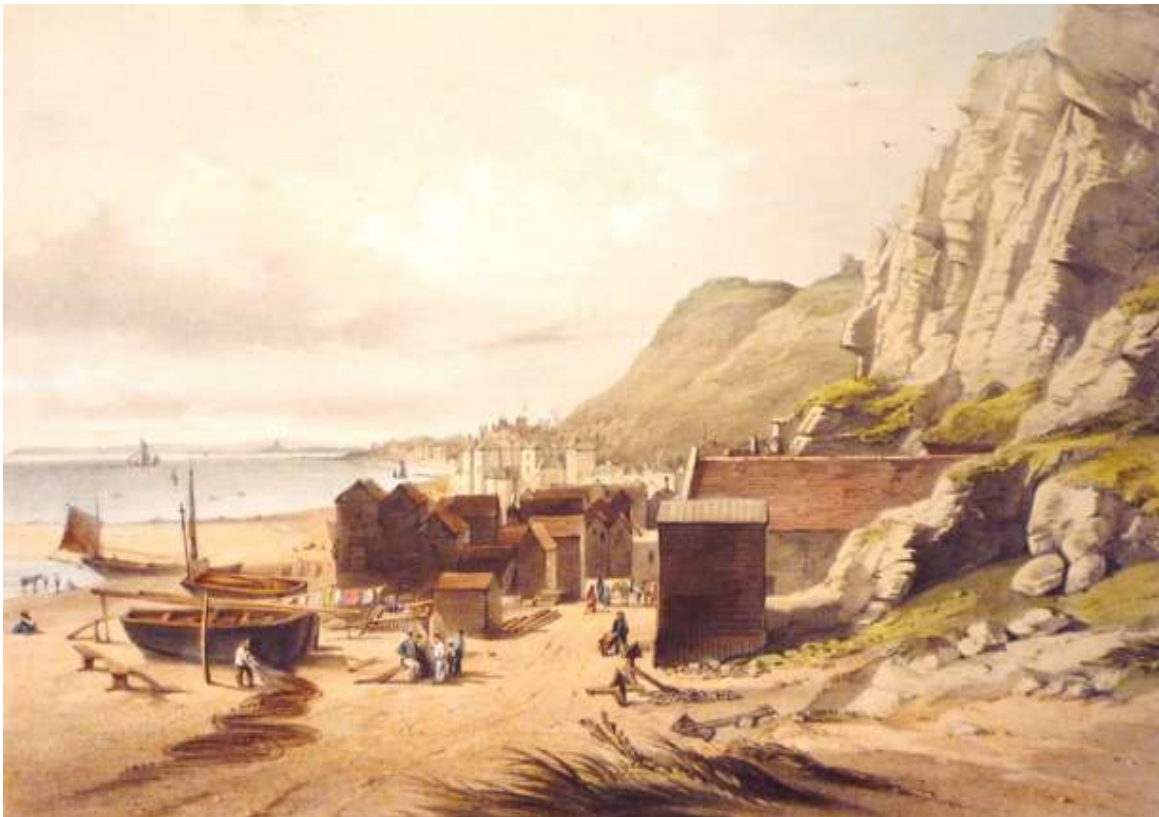
Figure 3C13. This lithograph, published in about 1850, looks westwards from below the cliffs and shows the fishing village and town beyond. The cliffs in the foreground are well-jointed and crumbling; the beach looks extensive at this time. Private Collection

The lithograph of the eastern end of Hastings beach (Figure 3.13) is relevant in this respect because it shows the extent of the beach in the mid-nineteenth century. It has been increasingly recognised that it is necessary to take a long-term perspective when looking at coastal issues and to understand the processes of coastal evolution over time. By making decisions about coastal risk management policy, looking ahead for the next 100 years, it is important to understand the rate and scale of change over time, and images of this kind can help explain beach conditions in the past.

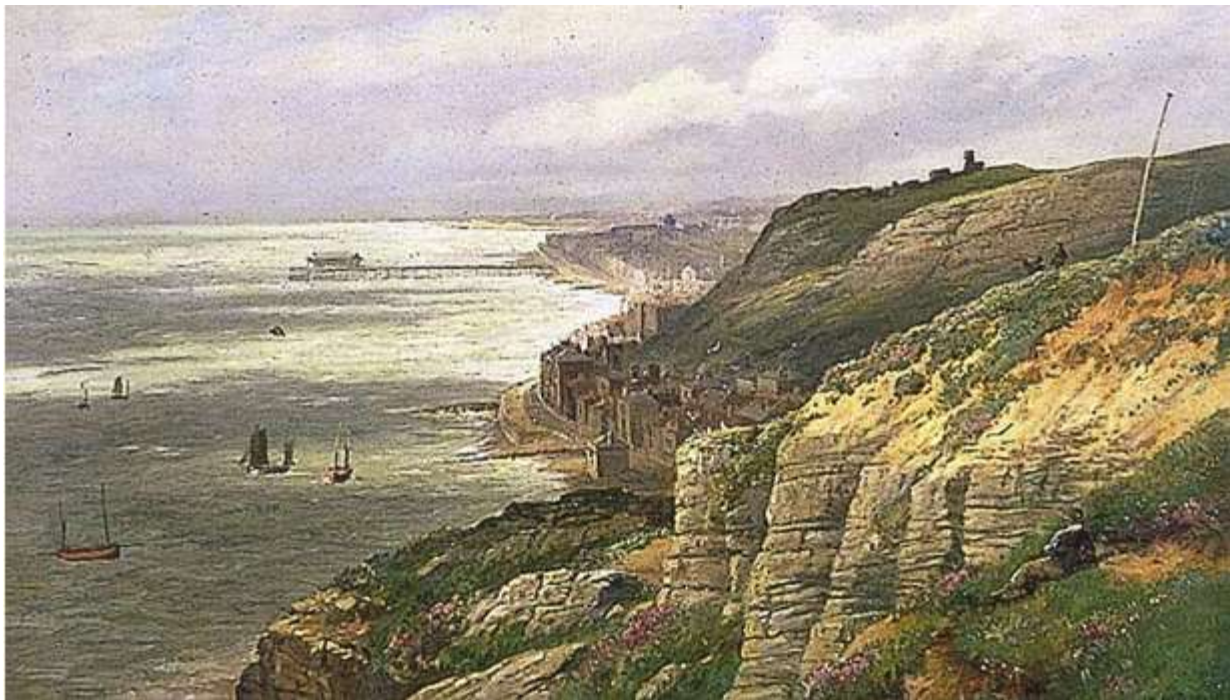
Figure 3C14. A panoramic view by W. H. Borrow from the top of the cliffs looking westwards in 1881. The geology is carefully painted and shows the dipping, jointed strata. The scene is painted at High Water as the sea abuts the promenade. Image courtesy of Hastings Museum & Art Gallery

As well as considering the impact of erosion and historical sea level rise on Hastings amenity beach the study area included a weak sandstone cliffline at the eastern end of the town (see Figure 3C14). The cliffs are composed of sandstones, which are susceptible to the processes of weathering, and erosion at their toe by the sea along the undefended sections. The jointing in the cliffs means that sections are prone to breaking away in massive blocks and causing toppling failures. Once the material falls onto the beach, it is quickly removed by the sea, enabling the cycle of events to initiate once again. Ground water, soaking through the permeable cliffline and emerging at different points through the cliff face, is also an important process which speeds up the instability problems.

Images of coastal cliffs such as those by W.H Borrow of Hastings to Fairlight (eg: Figure 3C.14) can contribute very usefully to this understanding by showing the state of the cliffs over time.

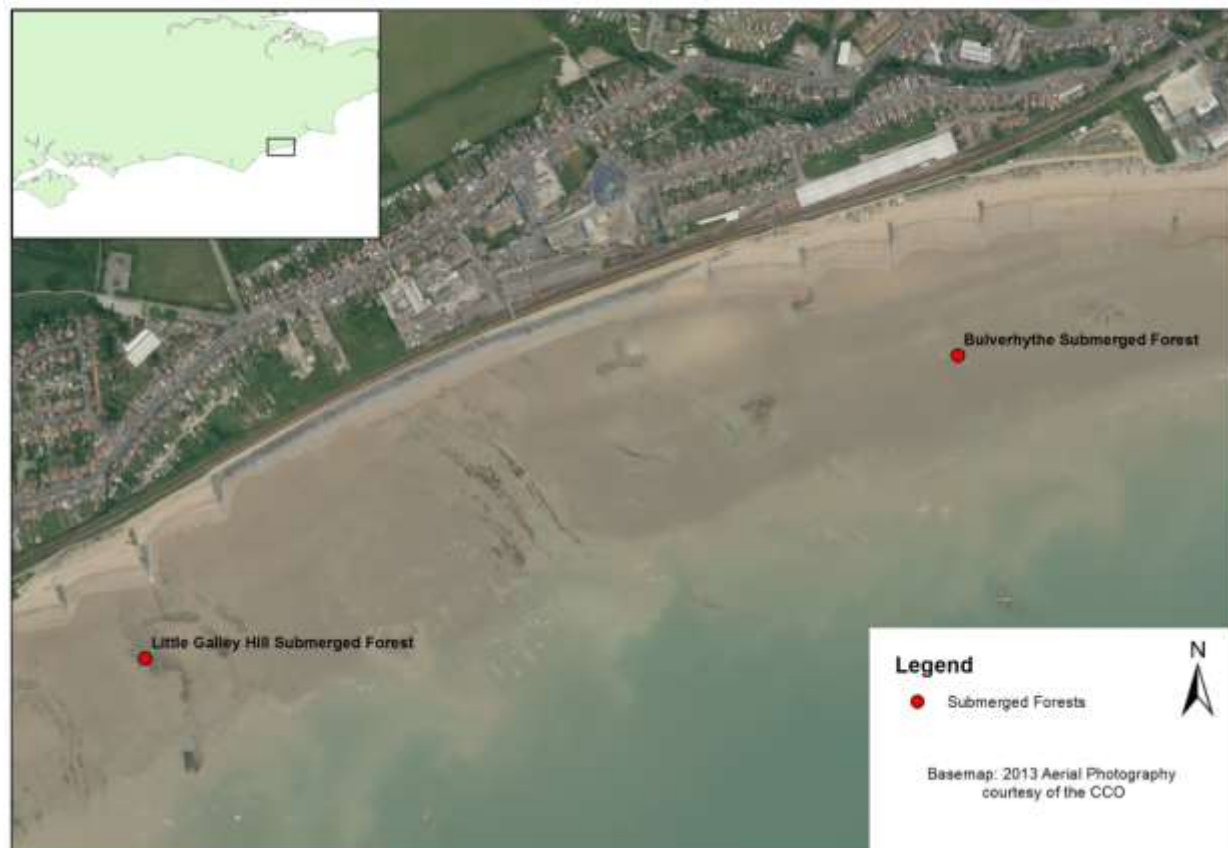
Figure 3C15. Aerial photo of Hastings showing the high ranking submerged forests of Little Galley Hill and Bulverhythe within the Hastings study area

The archaeological and palaeoenvironmental data from the Hastings case study area can provide detailed information on the changing coastline from prehistory to more recent times. In particular, high ranking sites such as the dated submerged forest off Little Galley Hill provide key information on changes in sea level and the environment since the Bronze Age. Nearby the submerged forest at Bulverhythe is now exposed at low tide although the exact dates are unclear. These sites are now 150-230m from the current high water mark. The site of Little Galley Hill contains remains of an oak and hazel forest and the site of Bulverhythe contains deer antler which is thought to have been worked as well as 13th Century pottery in the upper peaty layers. Further east the submerged forest just south of Pelham place contains leaves, hazel nuts, acorns, oak and deer antlers.

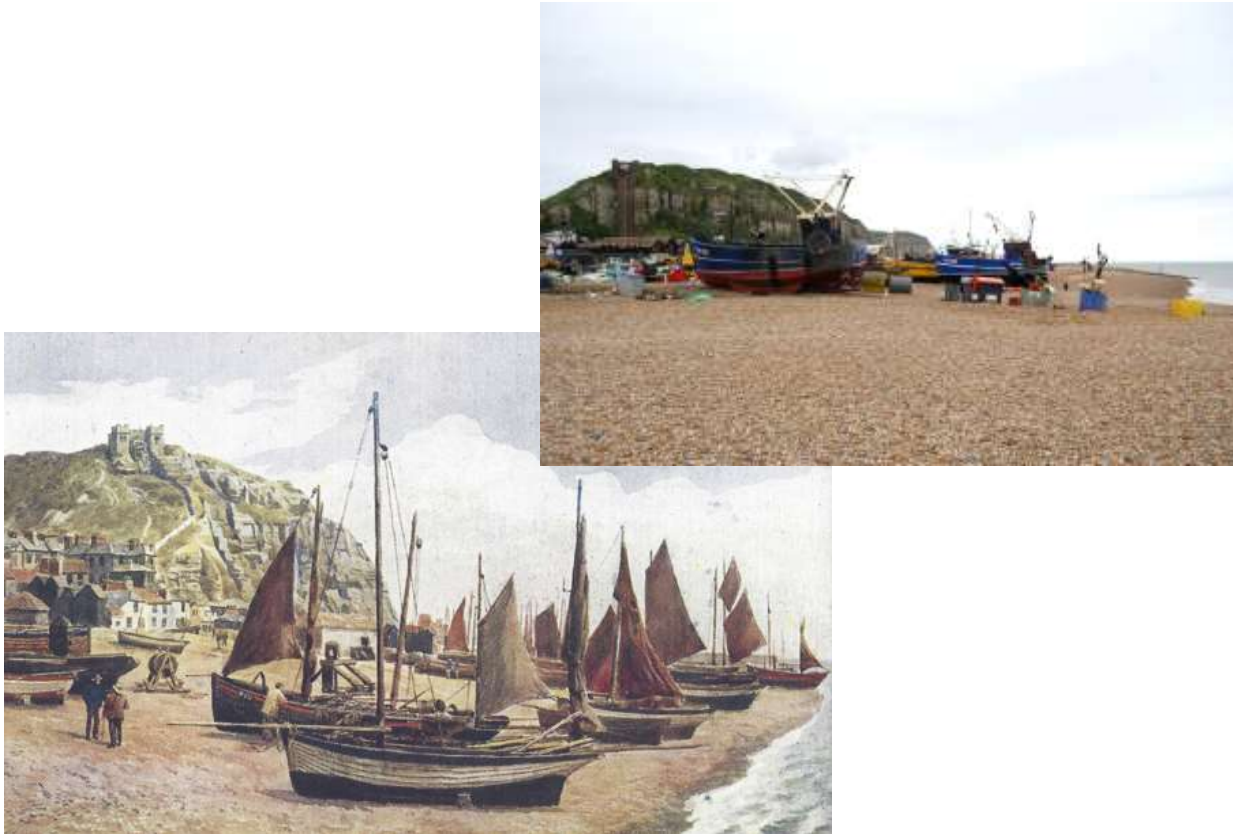
Figure 3C16. A view from Hastings Beach, comparison of the high ranking 1920's painting (Courtesy J.Salmon Ltd) with a current photo (copyright N Chadwiick). Raised beach levels can be seen

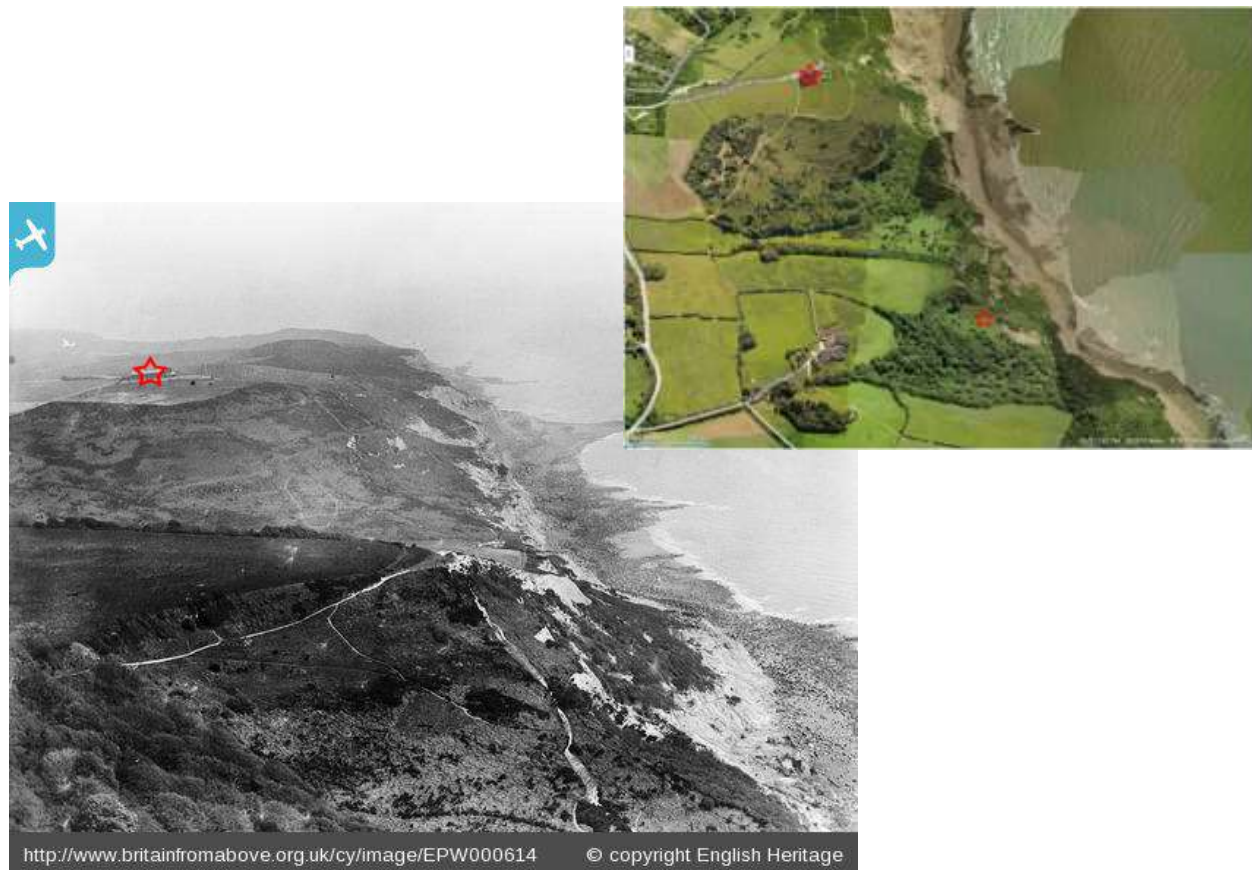
Figure 3C17. The image on the left shows the view eastwards from Willowpit Wood, the Fairlight coastguard station can be seen in the distance (red star), the modern image on the right shows the current position of the coastguard station in the background, and the approximate position of the photographer above Willowpit Wood in the foreground (red stars). (Historic image © English Heritage)

Historic photographs and maps/charts have also provided key information on coastal change. Figure 3C177 shows a 1920 image of the Hastings coast looking east towards the Fairlight coastguard station and a modern day aerial photo of the same area. Although it isn't possible to take exact measurements it does show that the cliff south of the coastguard station has retreated, the erosion of these soft cliffs is also noted in the Shoreline Management Plan (SMP).

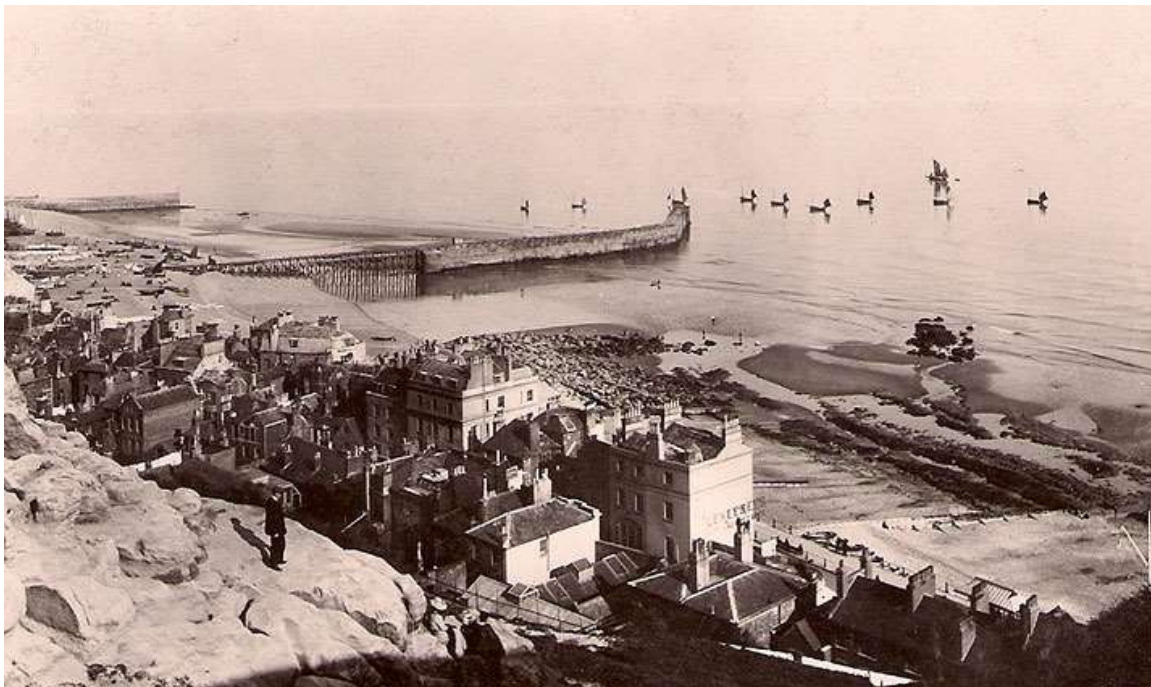
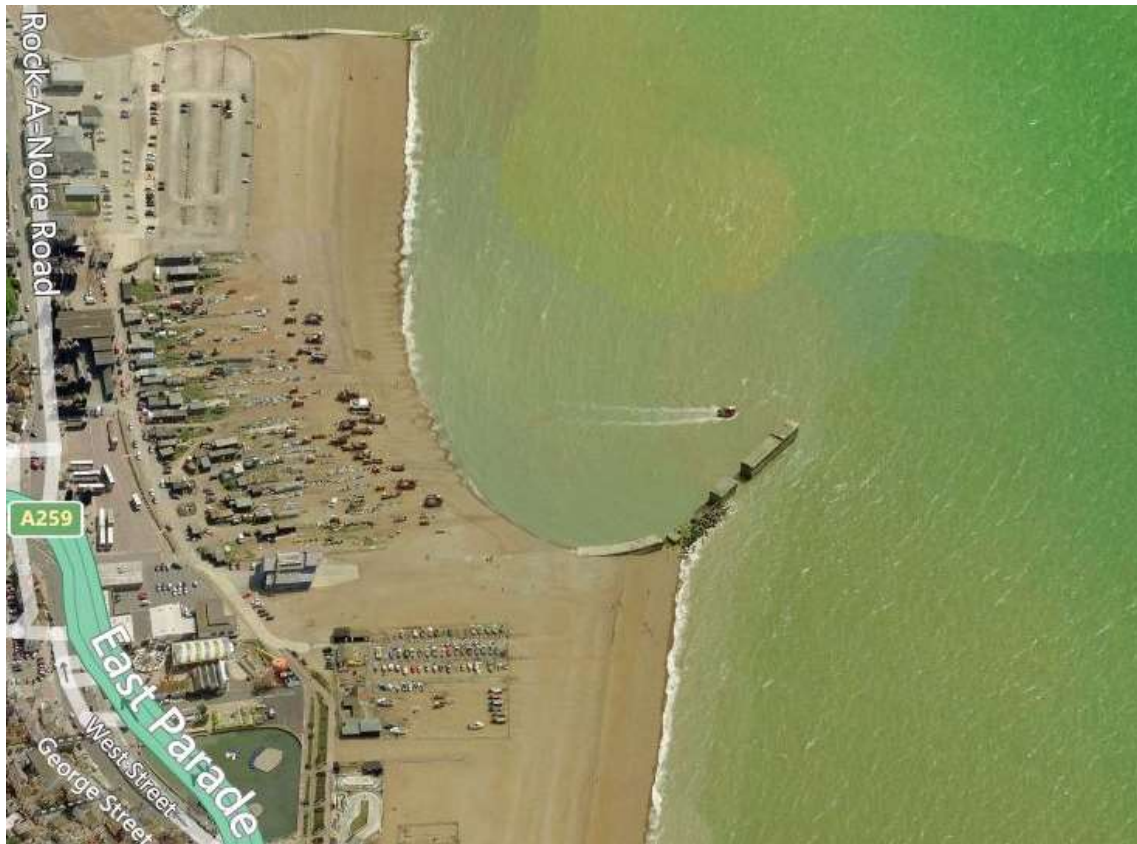
Figure 3C19 (A&B). The top photo (A) shows Hastings Harbour Arm in 1918, below (B) is a present day aerial image.

One example of this is the harbour wall. In the late 19th century the harbour Commissioner began construction of a harbour, however, due to the nature of the seabed and the inadequate financing work was stopped. The harbour arm is the remains of this construction attempt and has protected the beach and town for both tourism and fishing. As mentioned above the current SMP proposes that the arm is maintained in order to continue this protection. Historic photos and maps can help us to understand the sediment regime and the impact of the arm on the coastal processes along this frontage. In Figure 3C19 you can clearly see how sand has built up against the arm since the photo was taken in 1918, the timber section is now completely covered by sand and shingle.

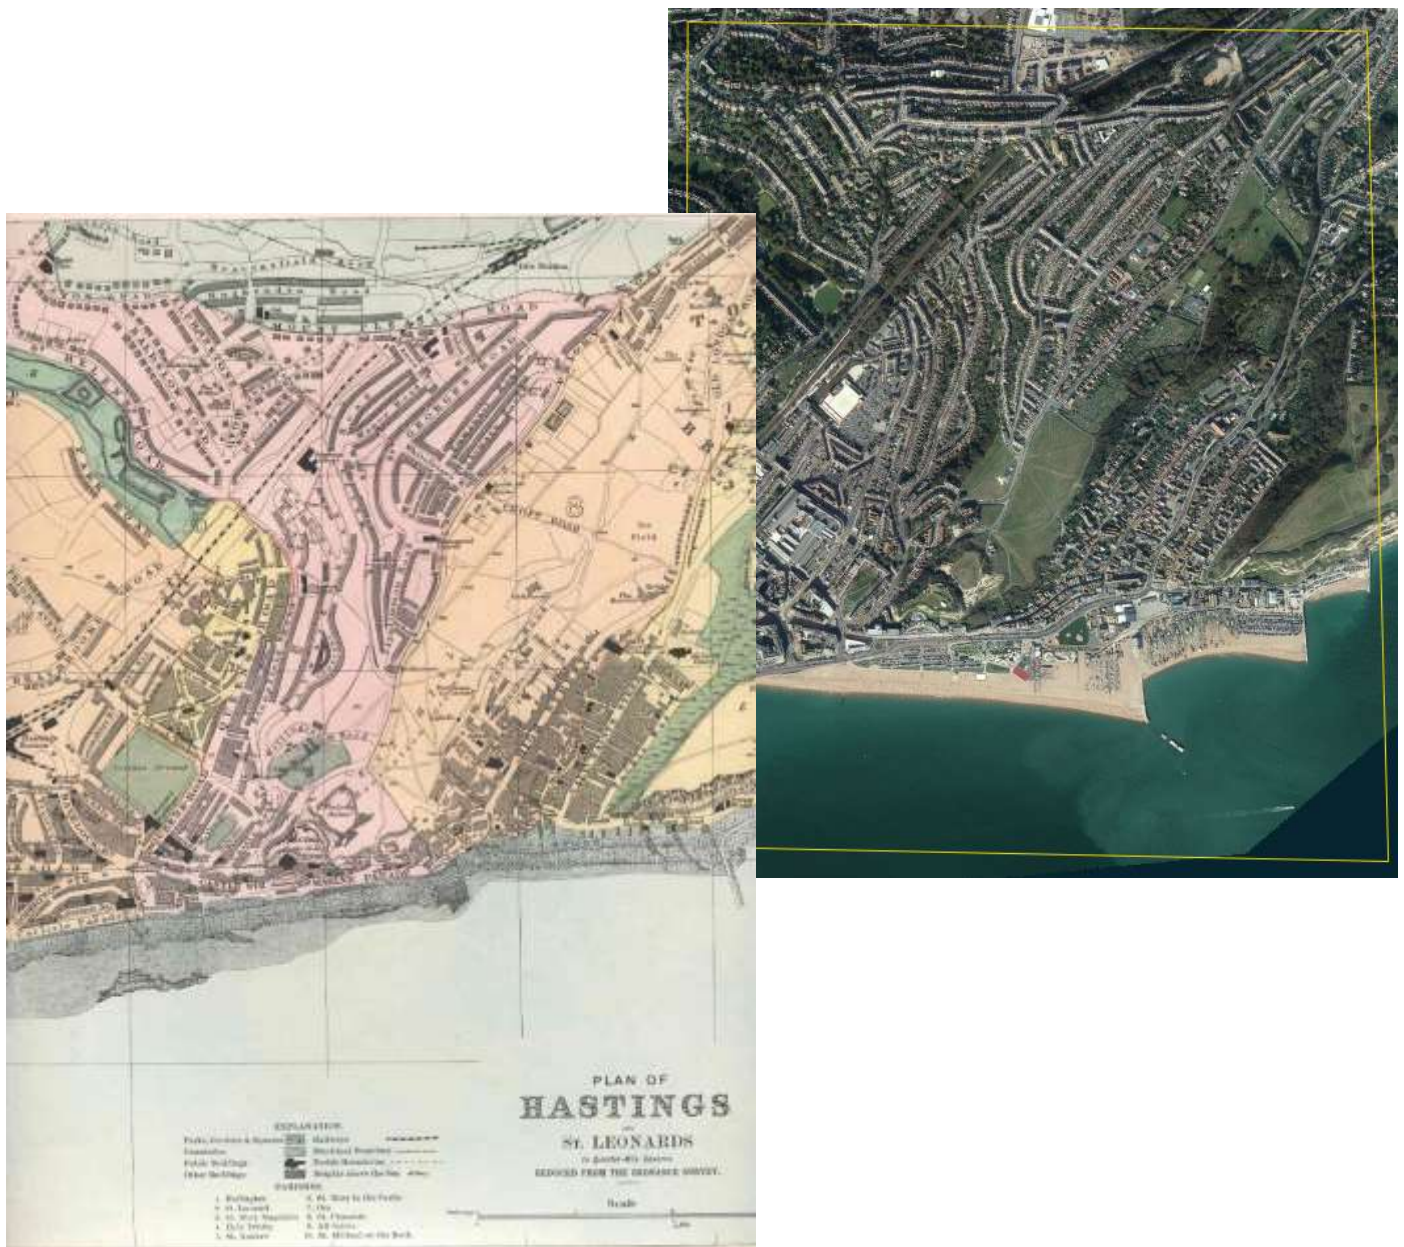
Figure 3C20. Plan of Hasting and St Leonards (left) Bacon 1890. Aerial photo of the same area, the yellow box marks the area covered by the 1890 plan (right).

This area is also depicted in a map from 1890 prior to the building of the harbour arm, compared to a modern aerial image it is clear to see how the sediment has built up and provided a larger beach in the area around the harbour arm.

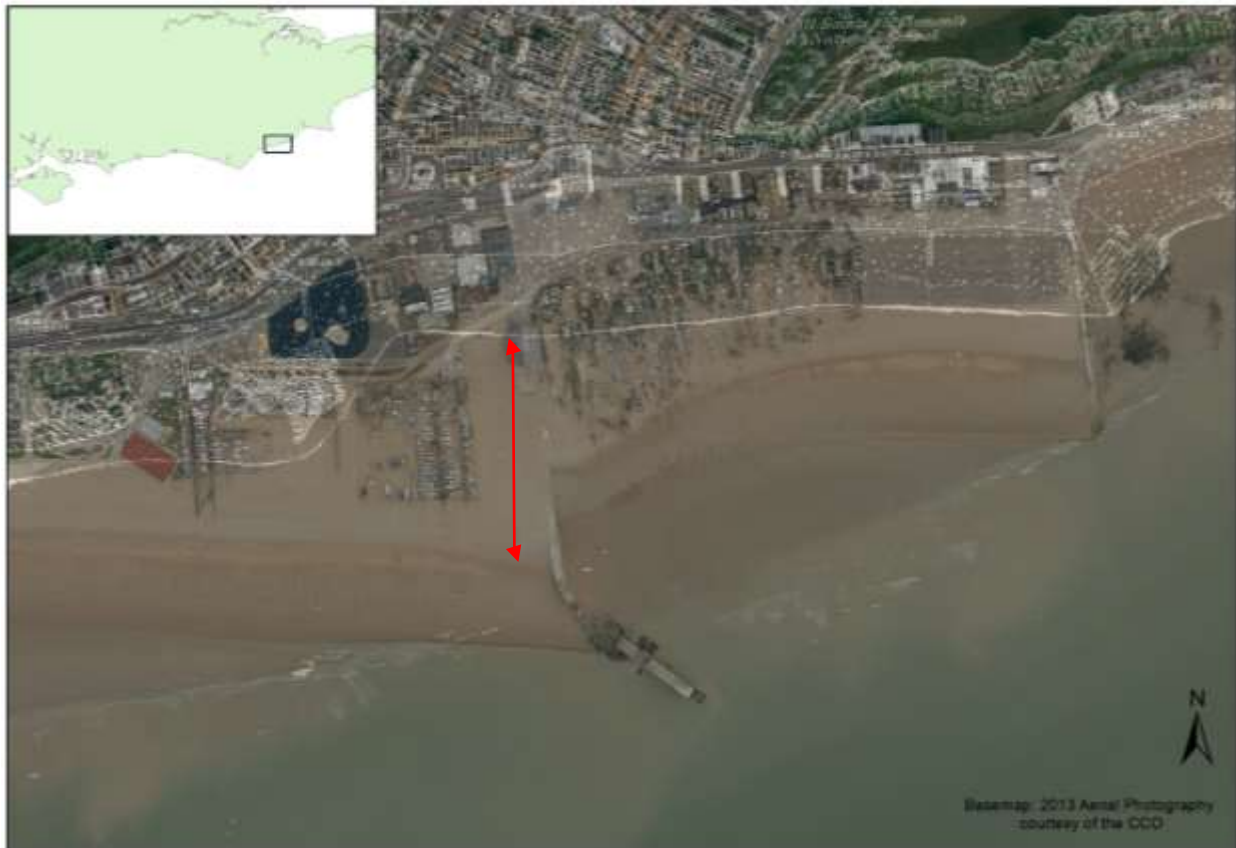
Figure 3C21. 1st Edition OS Map overlaid on 2013 photography. The red arrow depicts the changing high water mark

The addition of the humanly constructed feature – the Harbour arm has clearly impacted the coast with increasing sediment levels and creating a shoreline which is artificially seaward of its natural position.
