## CASE STUDY 3E - WEST DORSET AND EAST DEVON

**Case study area:** West Dorset and East Devon, UK.

**Main geomorphological types:** Harder and soft clifflines, shingle and sandy beaches

**Main coastal change processes:** Coastal erosion, landsliding, beach change, sea flooding

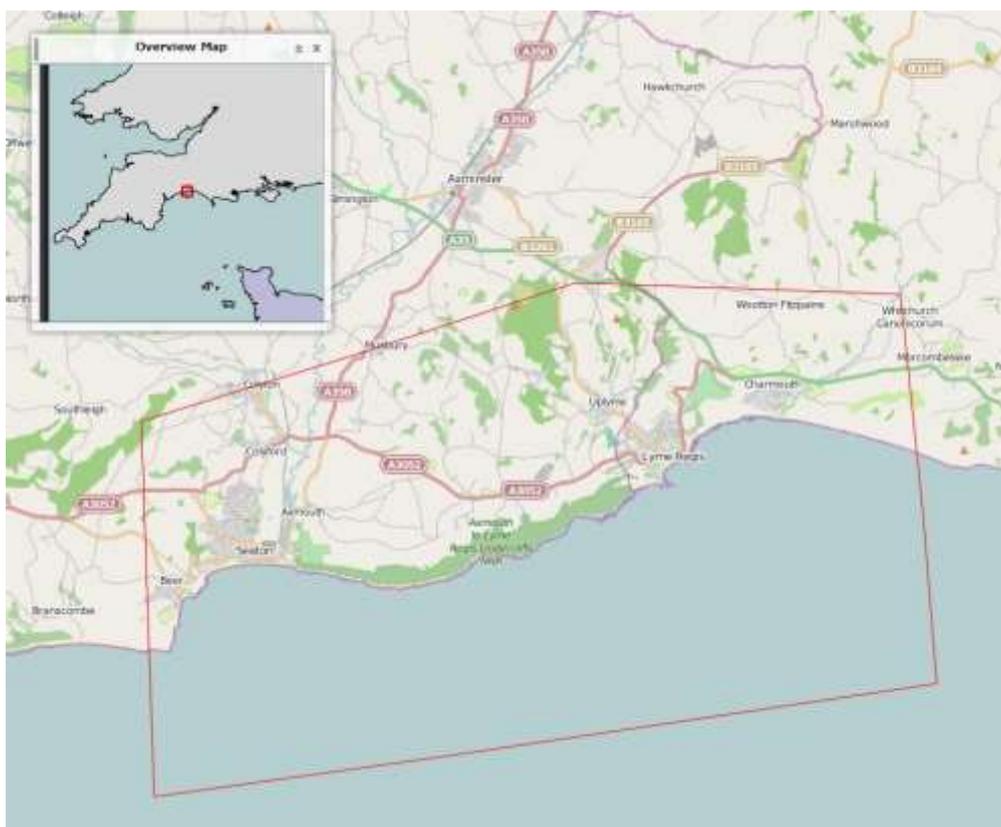
Figure 3E1: Map of the West Dorset and East Devon case study area

Within the study area the available art resource has been researched, ranked and analysed. The extents of the detailed study areas are shown in Figure 3E1 below.

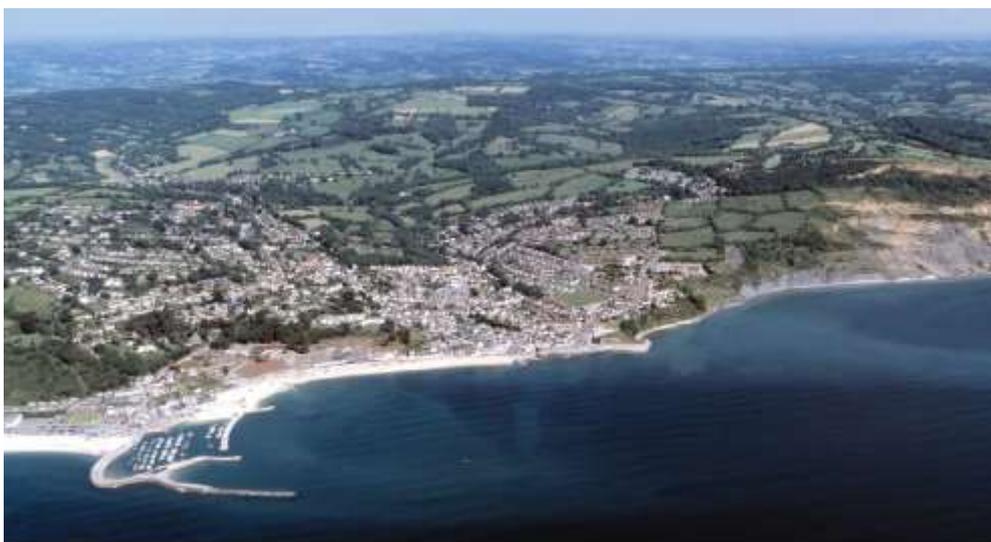
*Figure 3E2: A view looking eastwards along the Lyme Regis Dorset frontage. To the east of the town is the landslide complex of Black Ven. Further east is the village of Charmouth whilst the eastern end of the study site is at West Bay (out of photograph). Photograph courtesy of Wightlight Gallery.*

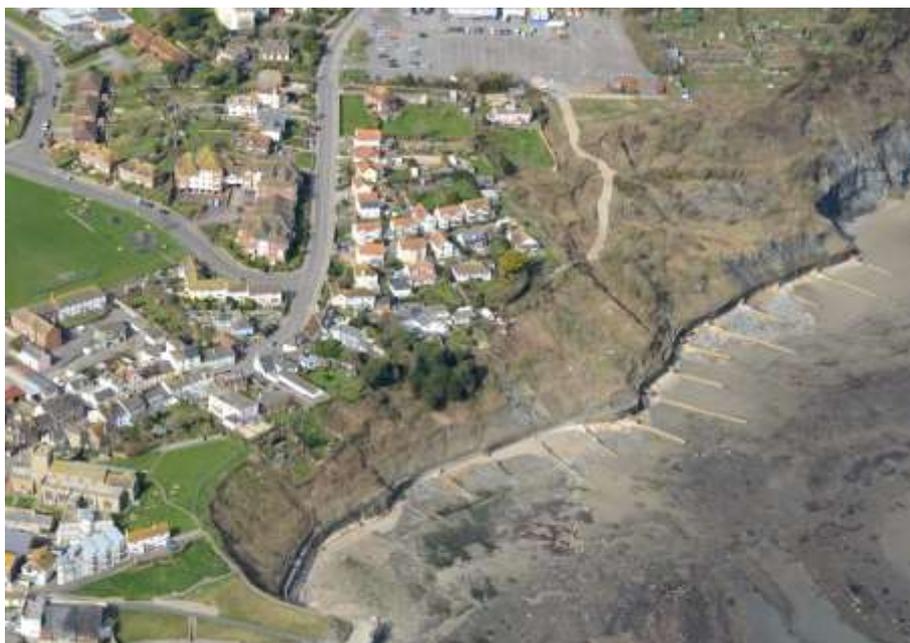
*Figure 3E3: East Cliff at Lyme Regis. Coast and cliff protection and drainage works are currently in progress in order to reduce risks for cliff top properties and assets. Photograph courtesy Halcrow CH2M HILL.*

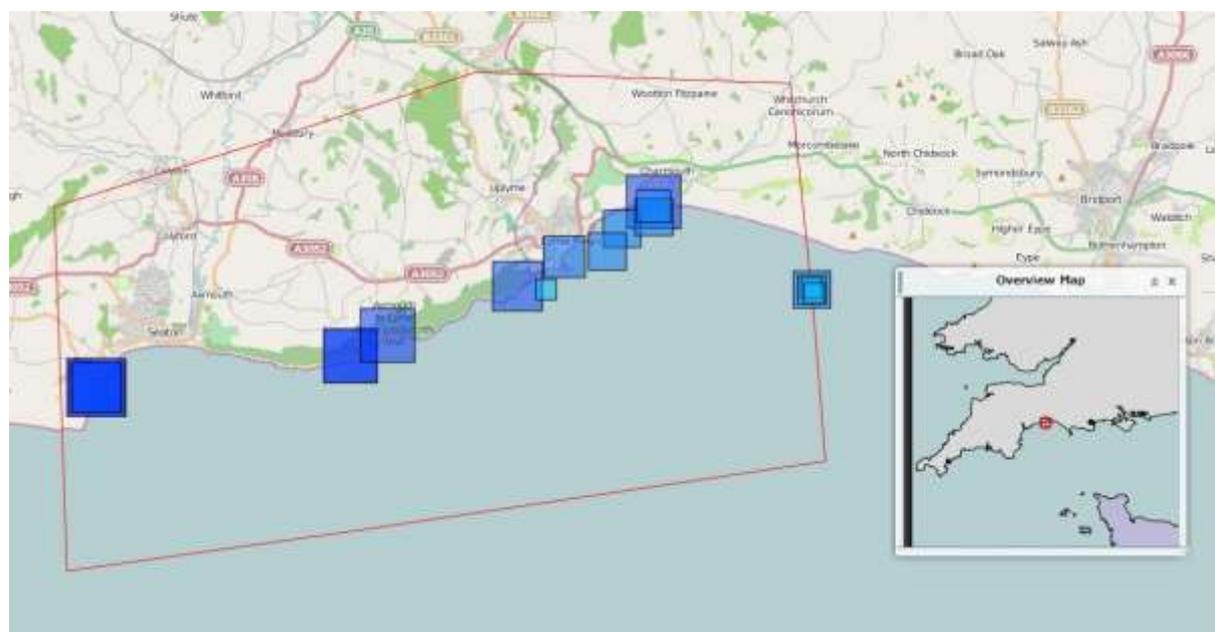
Figure 3E4. Location of artworks in the West Dorset and East Devon study area

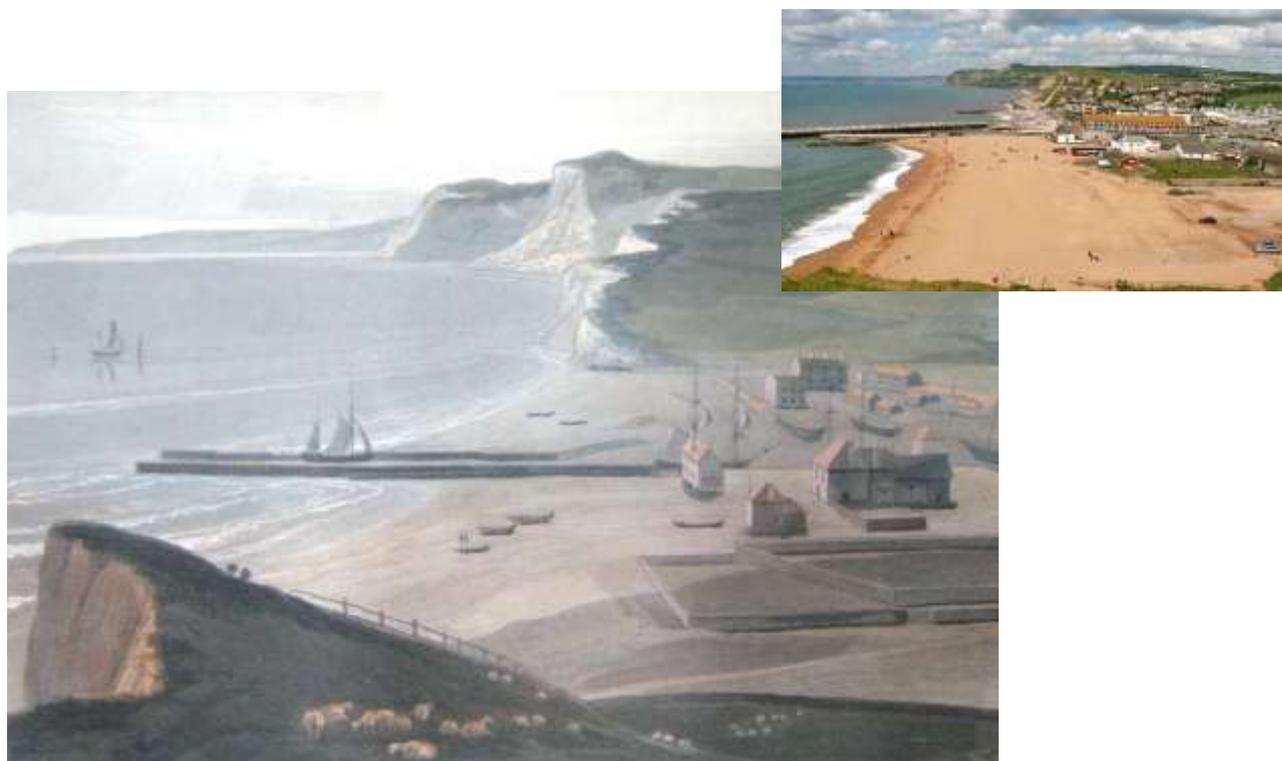
Figure 3E5: 'Bridport Harbour' (West Bay) by William Daniell RA (1825).

Figure 3E5a (inset top) shows the present day view with the much more extensive beach on the east side of the twin harbour arms compared with the western beach. Image courtesy of Halcrow.

The aquatint engraving by William Daniell (1825) shows a view of '*Bridport Harbour*', now known as West Bay, viewed from the hillside on the eastern side of the valley of the River Brit.

Since Daniell's view, the harbour has developed considerably for commercial, tourism and residential reasons. The engraving shows a ship passing through the two parallel harbour arms, which provide access through the beach to the harbour. The extent of the beach is well displayed in the early engraving and bears interesting comparison with the present day view.

In the view by William Daniell (1825) the differences in cliffline and beach volume either side of the harbour arms appear much less marked. This probably relates to the repair, infilling and upgrading of the harbour, which only took place at about the time of Daniell's visit in the mid-1820s. Improvements to the harbour may have led to increased wave reflection and scour and it has been estimated that this could have reduced beach volumes by 0.5million M<sup>3</sup> since the mid-nineteenth century (Brunsden and Moore, 1999). The situation at West Bay has necessitated beach nourishment to reduce erosion and more recently the implementation of a Beach Management Plan. Certainly, his view seems to indicate a more extensive beach on the up drift side rather than the down drift, which is what might be expected.

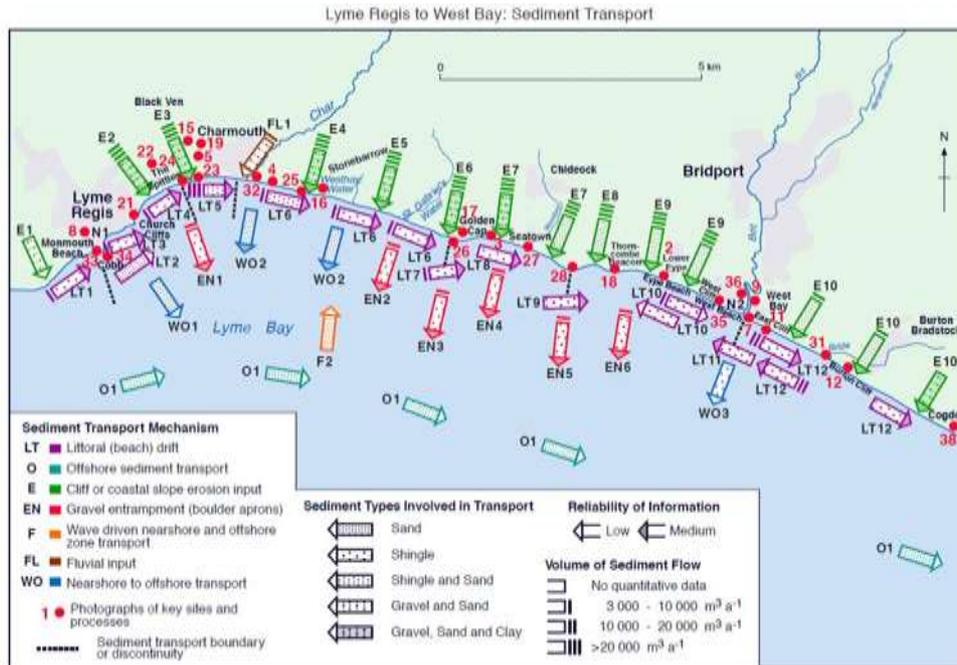
Figure 3E6: Sediment transport in Lyme Bay Dorset (SCOPAC: Bray et al., 2004).

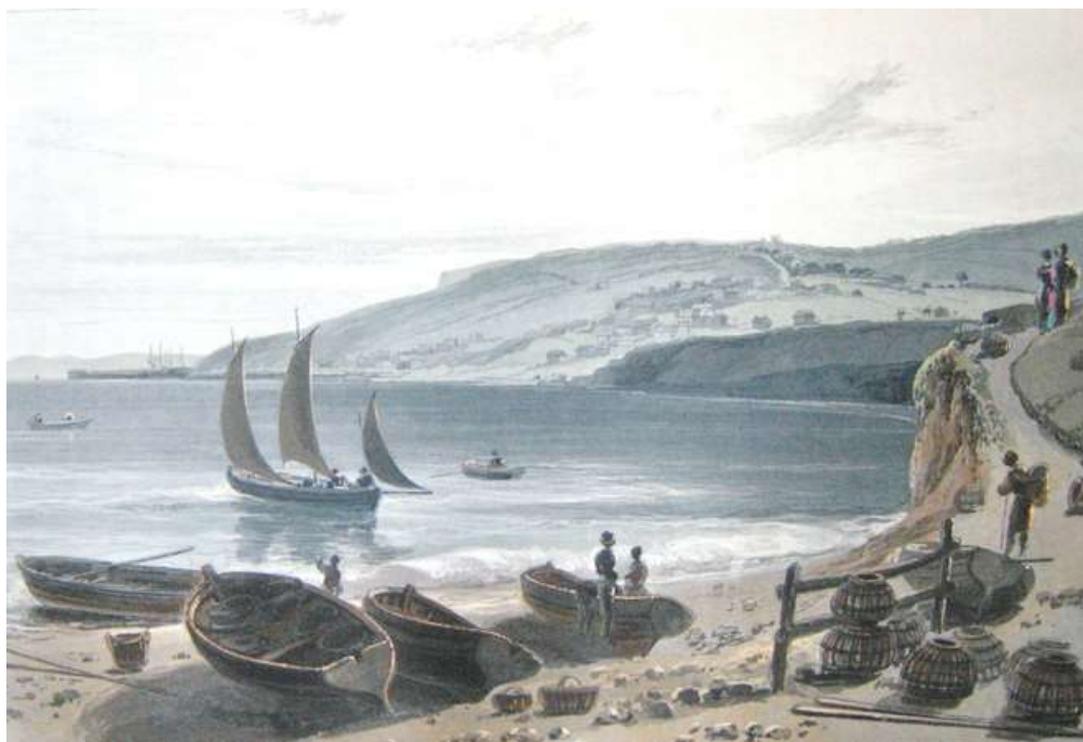
*Figure 3E7: 'Lyme Regis from Charmouth' by William Daniell RA; 1825. The view looks westwards along the study site frontage towards the harbour arm (The Cobb) at Lyme Regis. The Regency resort of Lyme Regis was starting to expand at this time.*

Daniell's view (Figure 3E.7) is taken from the western side of the beach at Charmouth at high water, looking along the coastline, past the Black Ven landslide complex towards Lyme Regis. In his view, the cliffline in the middle distance appears exposed (rather than vegetated), although there is no obvious evidence of cliff failure. He does, however, depict the lower part of the cliff in the middle distance in a darker colour, perhaps indicating the Blue Lias strata. The hillside beyond shows scattered development with the town of Lyme Regis round the headland. The image shows no obvious signs of instability and although Daniell refers to the fact that '*the cliffs in the neighbourhood contain peculiar attractions for the geologist*' (Daniell and Ayton, 1814) he does not mention cliff or slope instability. This suggests that perhaps the landslides were activated or reactivated during the nineteenth century as a result of changing climatic conditions, sea level rise and human activity.

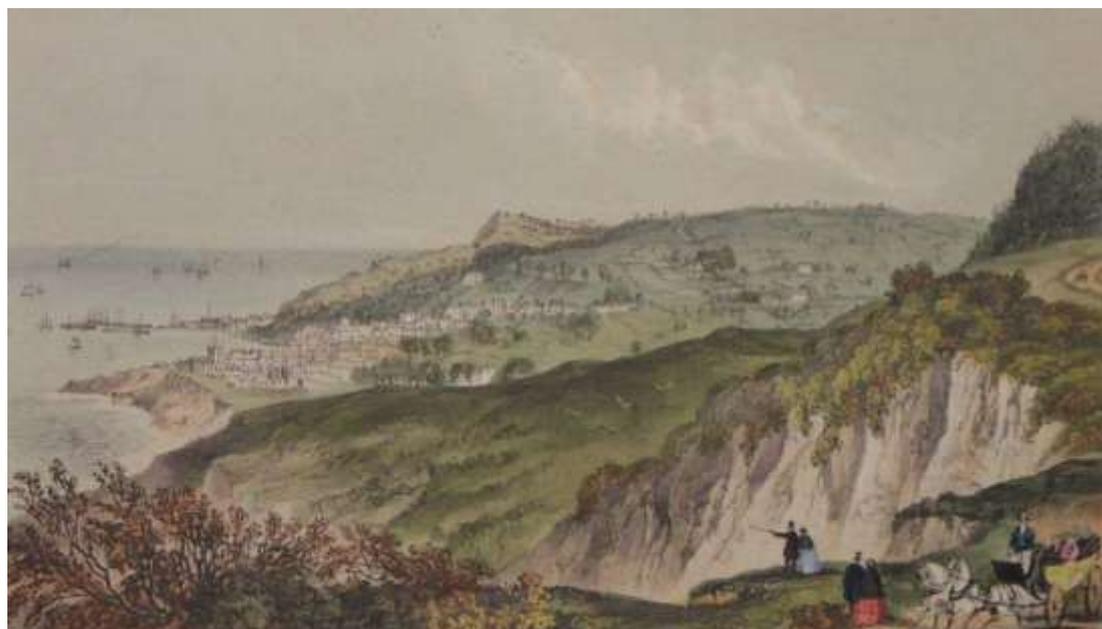
*Figure 3E8 'Lyme Regis' from the Charmouth road at the top of the cliff looking westwards across the town (by Daniel Dunster). The view is taken from above Black Ven, a very large coastal landslide. The town of Lyme Regis developed on an adjacent landslide complex. Image courtesy R.McInnes.*

The fine, lithographed view of 'Lyme Regis from the Charmouth road' (Figure 3E.8) by Daniel Dunster provides a detailed depiction of this part of the Dorset coast in 1840 and demonstrates the level of detail that could be achieved using this technique. The landsliding to the west of Lyme Regis towards Axmouth has been described and illustrated through the famous illustrated publication 'Memoirs and Views of the Landslips on the Coast of Devonshire &c.' (Conybeare & Buckland, 1840), which provides several detailed lithographic plates, maps and geological cliff sections as well as informative descriptions. These images and others (see Figures 3E.9 – 3E.12) and works by other artists have helped to understand

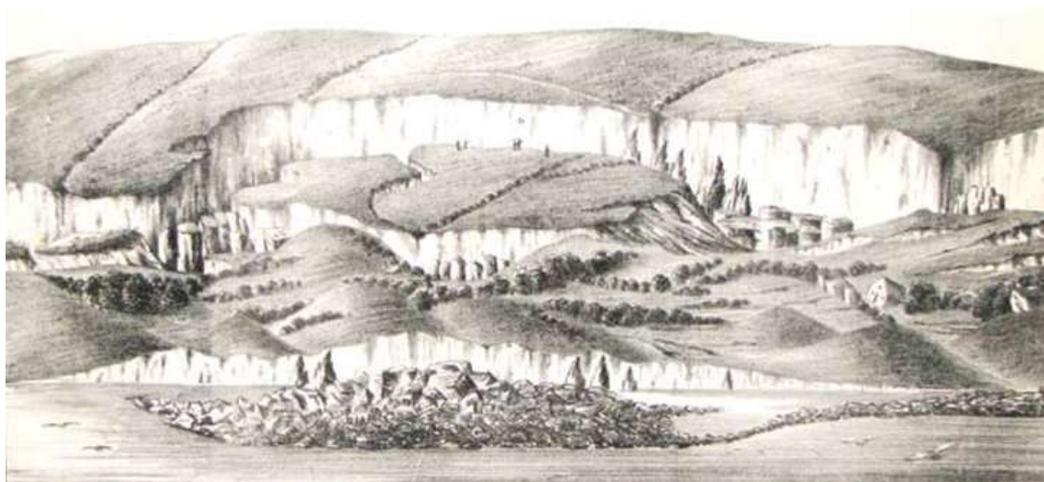
Figure 3E9 A view of the great landslide that took place at Bindon and Dowlands to the west of Lyme Regis on Christmas Day 1839. Image courtesy R.McInnes.

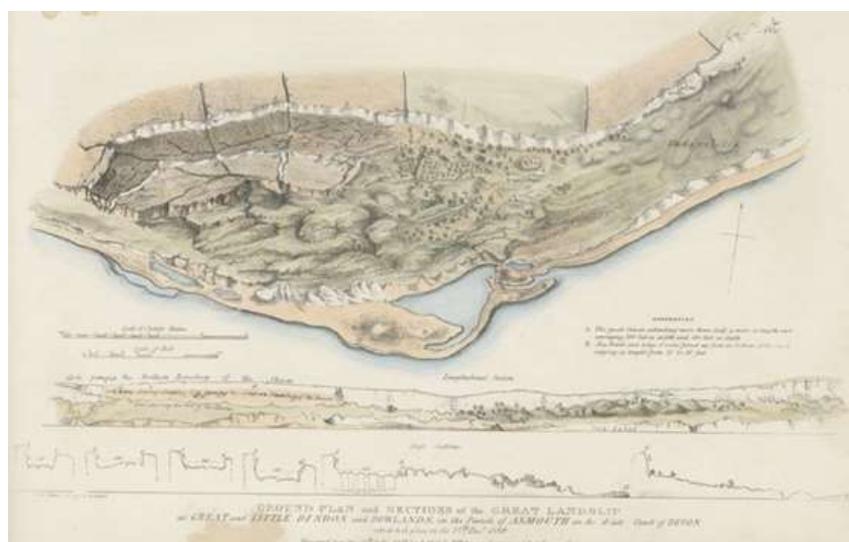
Figure 3E10: The area of the Bindon and Dowlands landslide was studied in detail and the geomorphology was mapped. Private Collection.

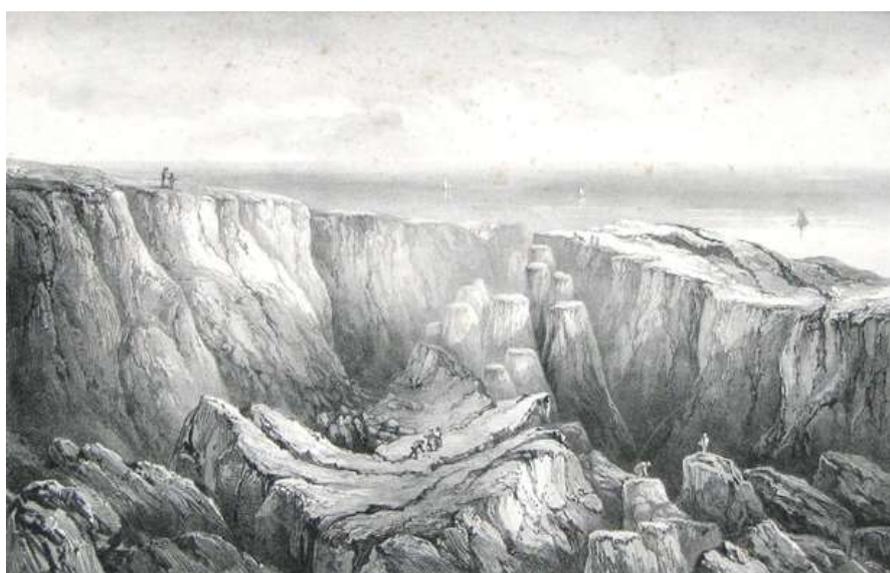
Figure 3E11: A further view of the landslide at Bindon and Dowlands is shown in this lithograph. Image courtesy R.McInnes.

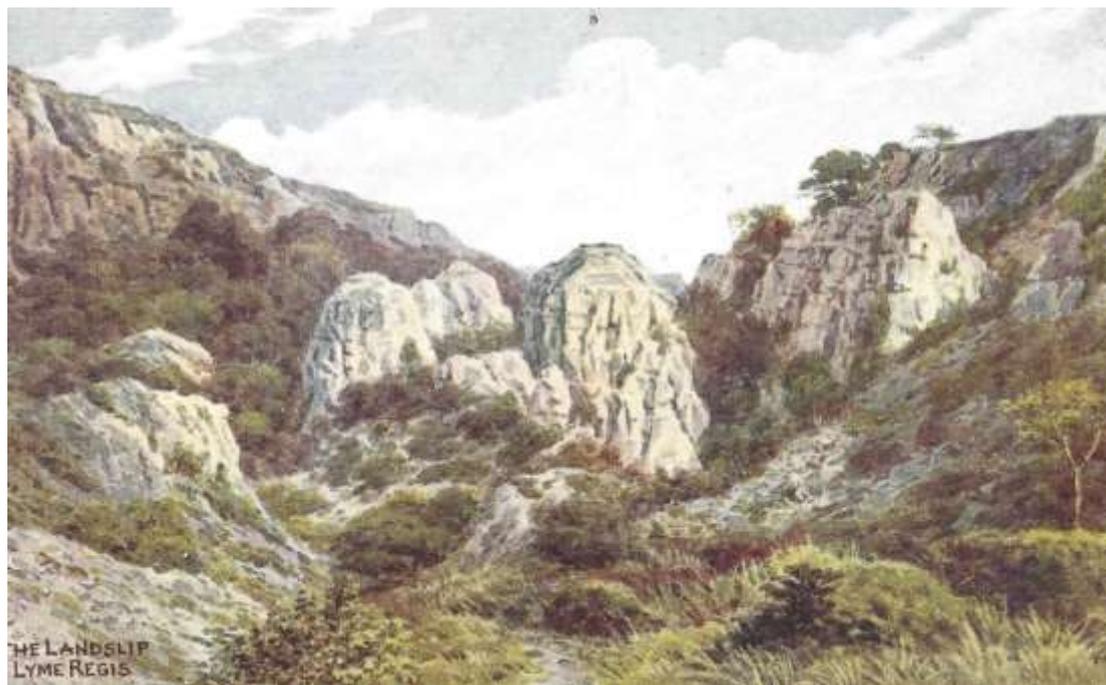
Figure 3E12: A view of the Bindon landslide by the prolific watercolourist Alfred Robert Quinton, c.1900. Image courtesy J. Salmon Ltd.

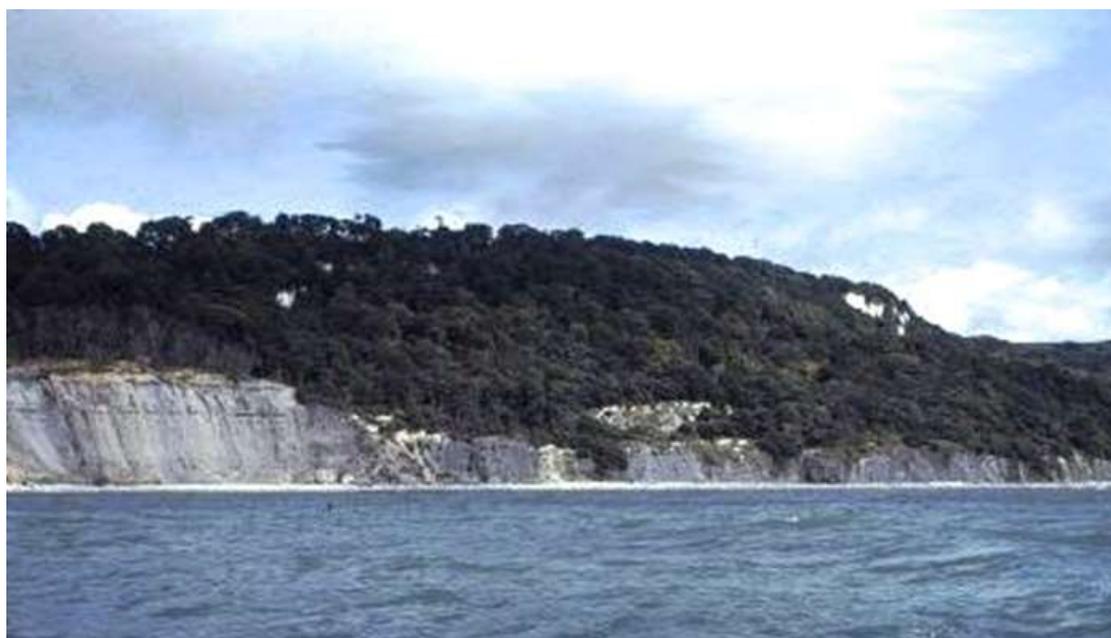
Figure 3E13: This view of the coast west of Lyme Regis shows how the geomorphology is now largely obscured by vegetation. The nineteenth century lithographers, therefore, allow the processes to be viewed more clearly and be better understood. Photograph courtesy: Ian West.

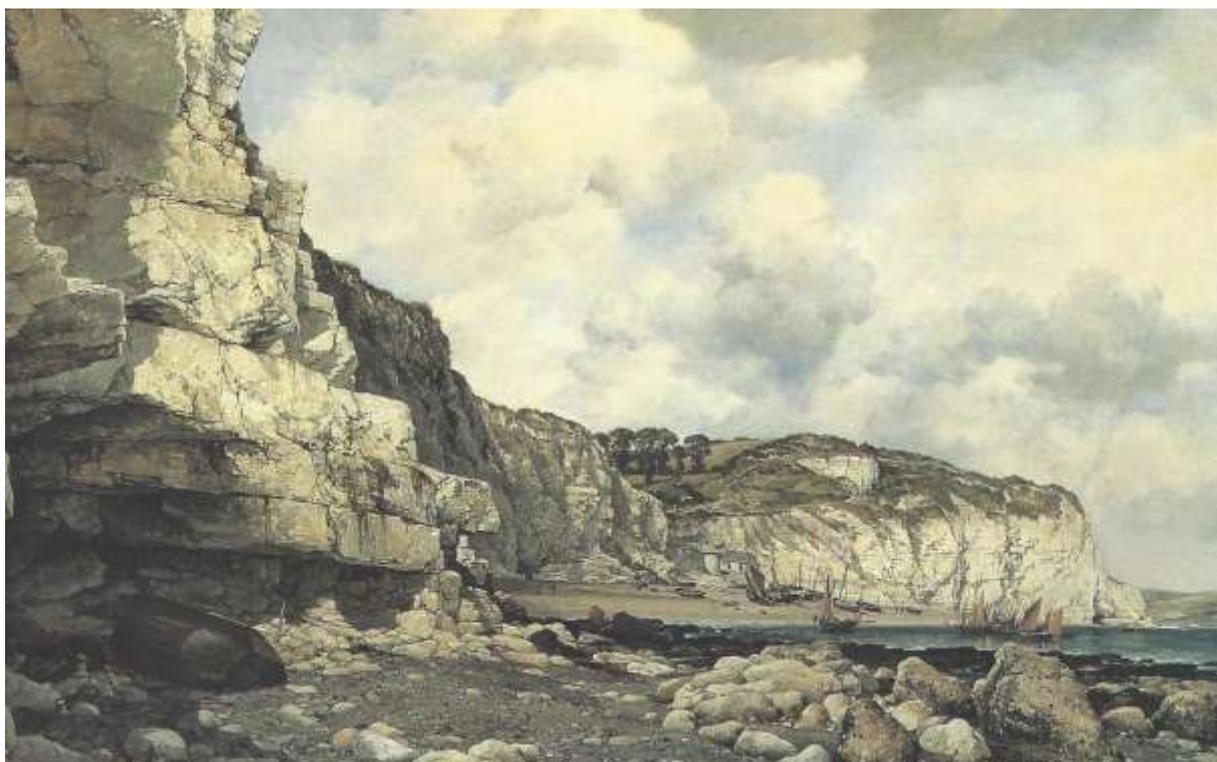
Figure 3E14: 'Fishing Cove of Beer' by Edward William Cooke RA; 1858. Cooke was very interested in geology and stated that he would have become a geologist were he not an artist. His oil paintings are remarkable for their clarity as well as the attention to geological detail. This view looks eastwards towards Dorset. Image courtesy of the late John Munday/Private Collection.

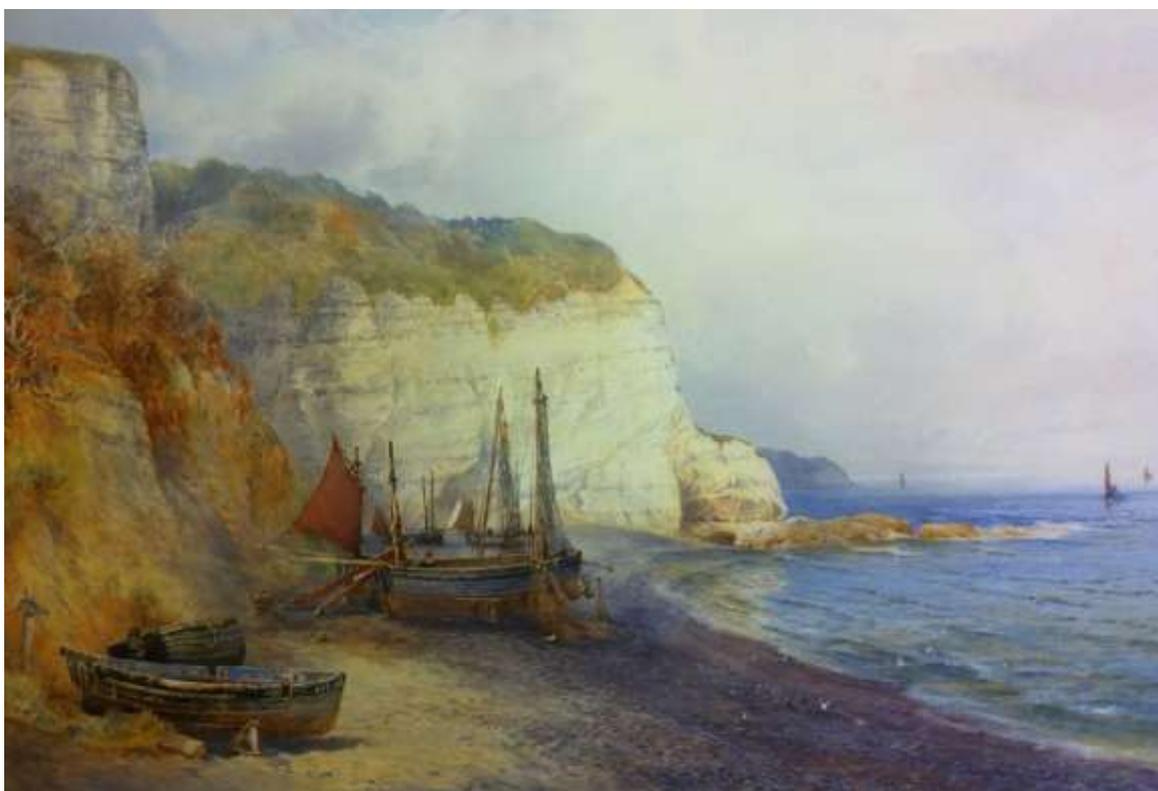
Figure 3E15: A detailed watercolour of Beer beach and cliffs by Arthur W. Perry (c. 1900). Image courtesy: Private collection. This is a similar view to that shown in Figure 3E.16 below.

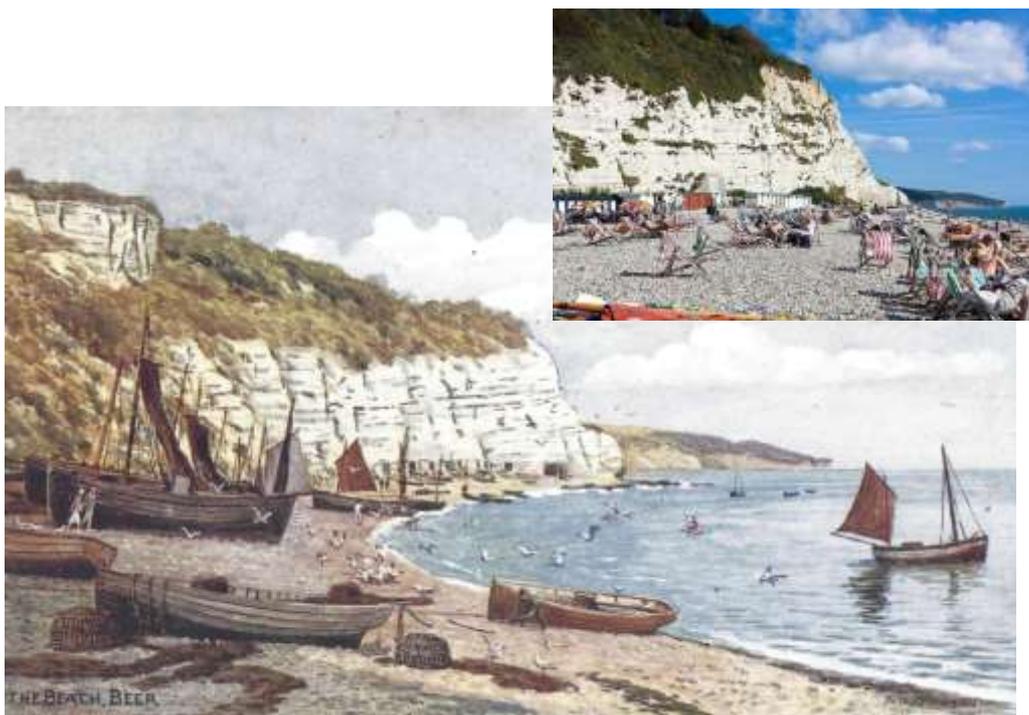
Figure 3E16: Watercolour by Alfred Robert Quinton also painted c.1900 (Image courtesy of J. Salmon Limited). And Inset Figure 3E.16a: the present day scene (courtesy of Ian Woolcock).
