CASE STUDY 3F – WEST CORNWALL

Case study area: West Cornwall, UK.

Main geomorphological types: Hard cliffs at the rear of sandy beaches.

Main coastal change processes: Beach change and potential coastal squeeze.

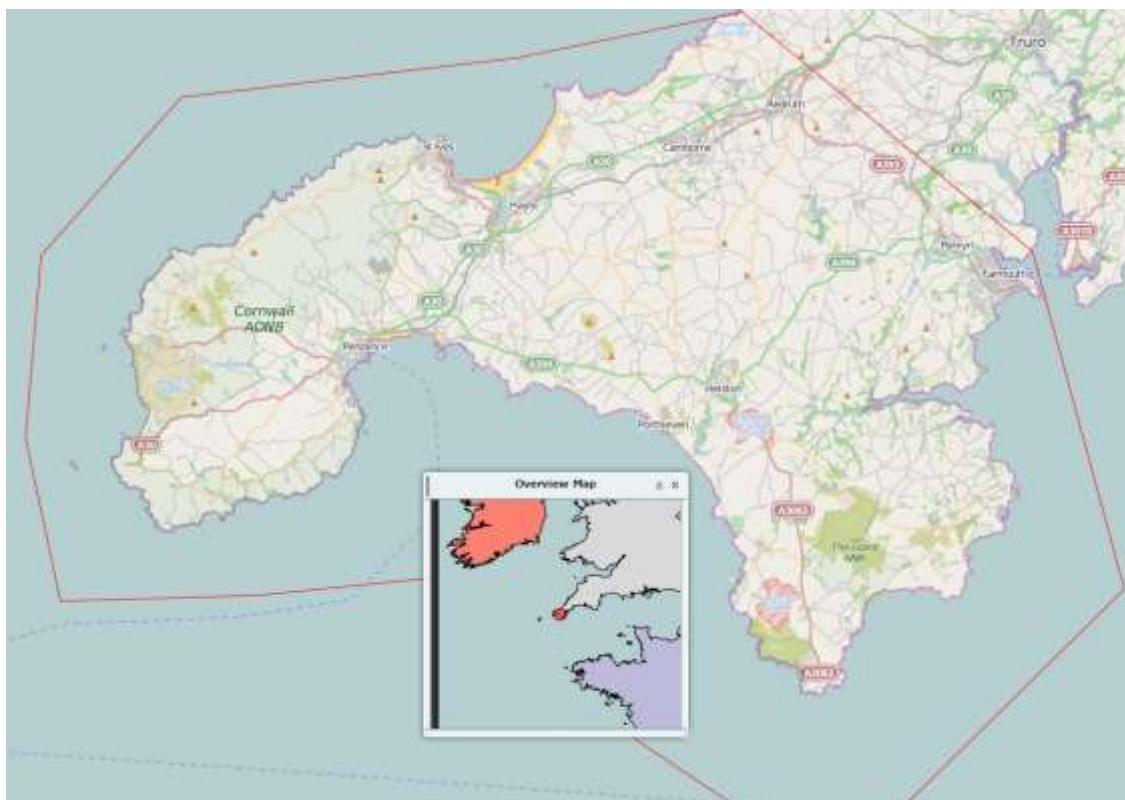
Figure 3F1: Map of the West Cornwall case study area

Within the study area the available art resource has been researched, ranked and analysed. The extents of the detailed study areas are shown in Figure 3F1 below.

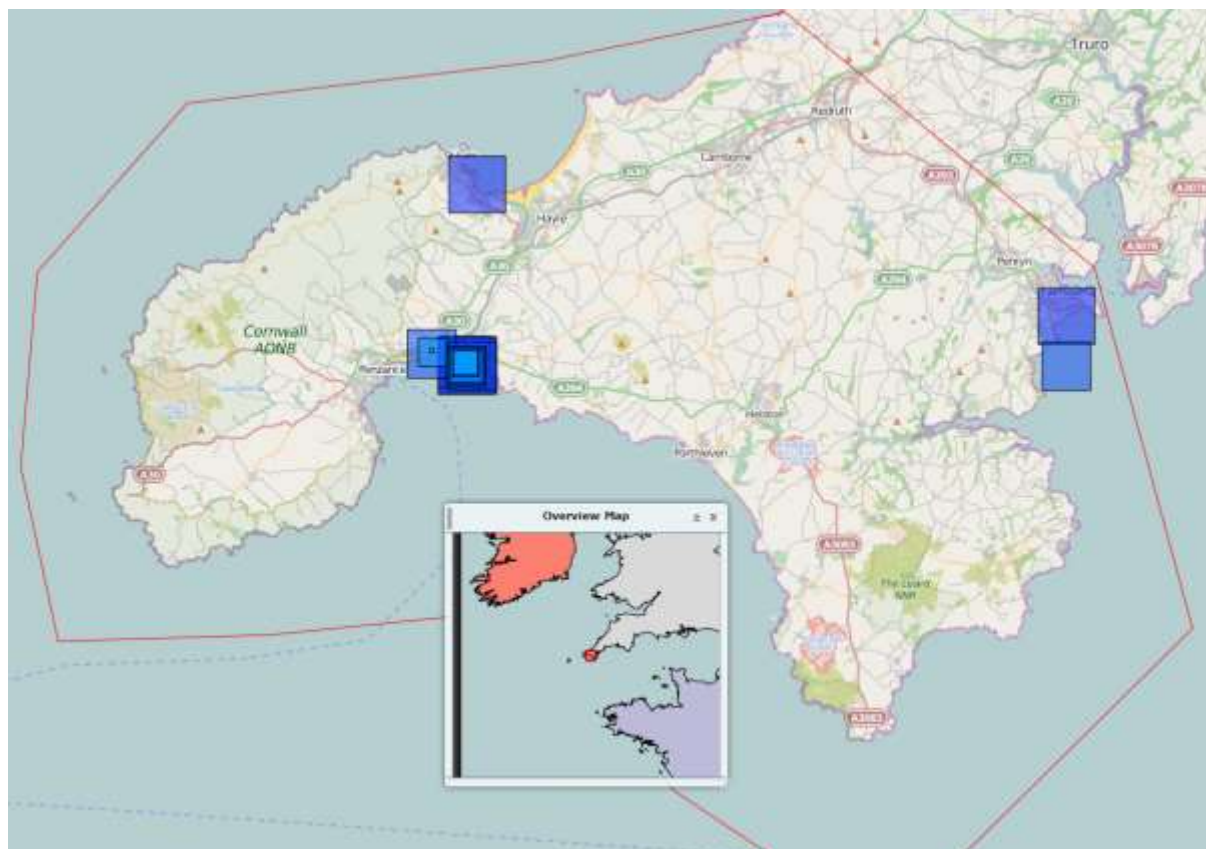
Figure 3F4. Location of the artworks.

The development of the ranking system has been outlined within [Section 2](#). In order to rank the artworks a database was established into which data was entered for both archaeological/maritime heritage sites and for artworks. By entering the data on artwork type, medium, subject matter, time period and other parameters the database was then able to calculate the ranking scores for twelve works of art from the case study site (Figure 3F4).

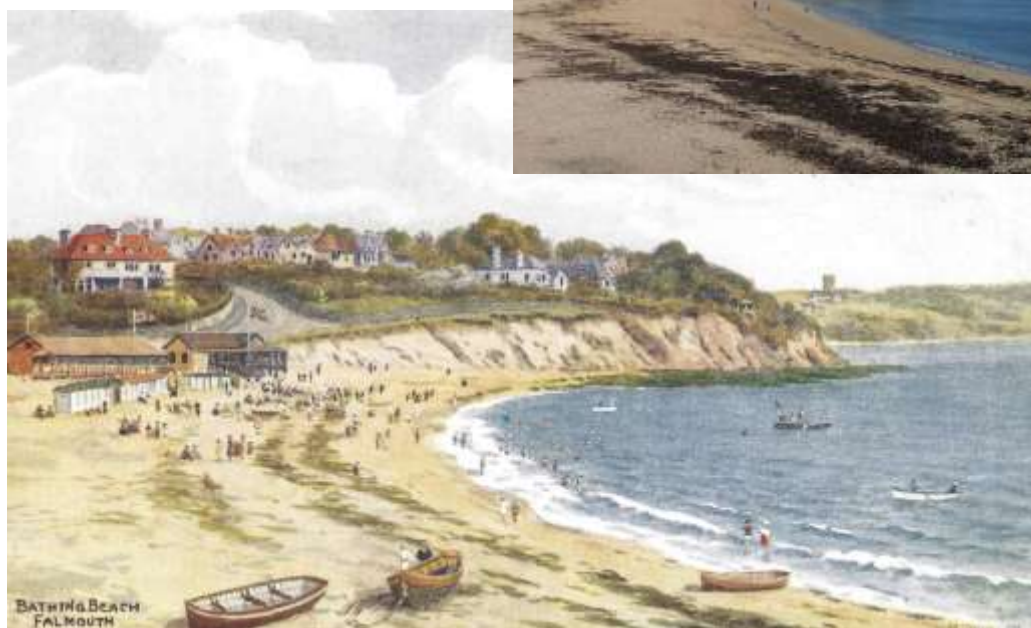
Figure 3F5: Gyllyngvase Beach near Falmouth, Cornwall by Alfred Robert Quinton; c.1900. Image courtesy of J. Salmon Limited. Figure 3F.5a: View of the beach today; image courtesy of Claire Ogden.

The artwork shows a view of the beach, looking eastwards, in about 1900. Both the watercolour by Alfred Robert Quinton and the present day view depict a healthy beach, although the view by Quinton is slightly closer, being taken from the middle of the beach. The cliff line in the centre of the watercolour seems rather more active than the present day, where the slopes are more vegetated. Overall, the image suggests relatively little change over the last 100 years, although there is likely to be some increasing pressure as a result of sea level rise, through the twenty-first century.

The artwork provides a representation of beach and cliff conditions in about 1900. It provides an indication of the nature of the beach some 30 years before the earliest aerial photographs became widely available. It does, therefore, provide a useful description of the beach at that particular time.

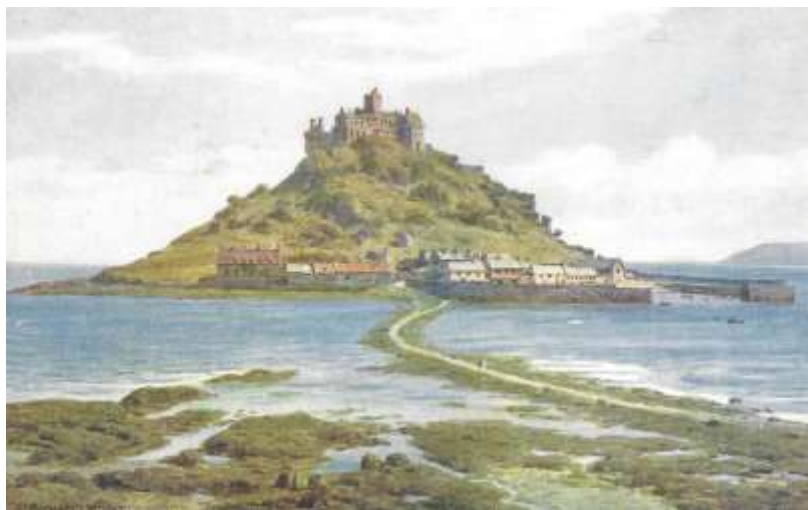
Figure 3F10 was painted by Alfred Robert Quinton in about 1900.

The two views of St Michael's Mount from the shore at Marazion by Alfred Robert Quinton (Figure 3F.10) and by Henry Wimbush (Figure 3F.11) were both painted in watercolour in about 1900. They depict the situation at low water, as evidenced by the visibility of the causeway linking the Island to the mainland, which is being accessed by pedestrians in the picture. In the foreground the rocky foreshore can be seen, which lies seaward of the sandy beach. The watercolours indicate the nature of the foreshore, and it appears that there has been little change since the view was painted.

Works by these artists have been proved to provide a reliable record of conditions at the time they were painted. Comparison of the image with the present day appears to show relatively little change and this is supported by evidence from monitoring of the frontage. The watercolours help provide a long-term perspective in terms of the nature of conditions at this important location.

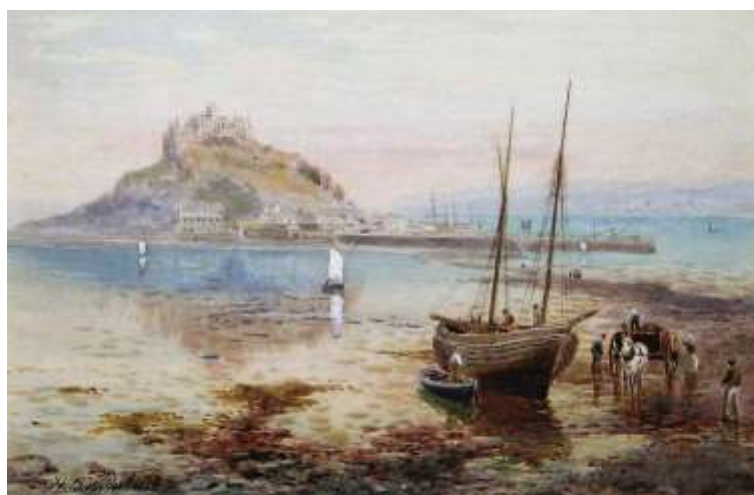
Figure 3F11: The view by Henry B. Wimbush and is of a similar date to Figure 3F.10 (image courtesy of J. Salmon).

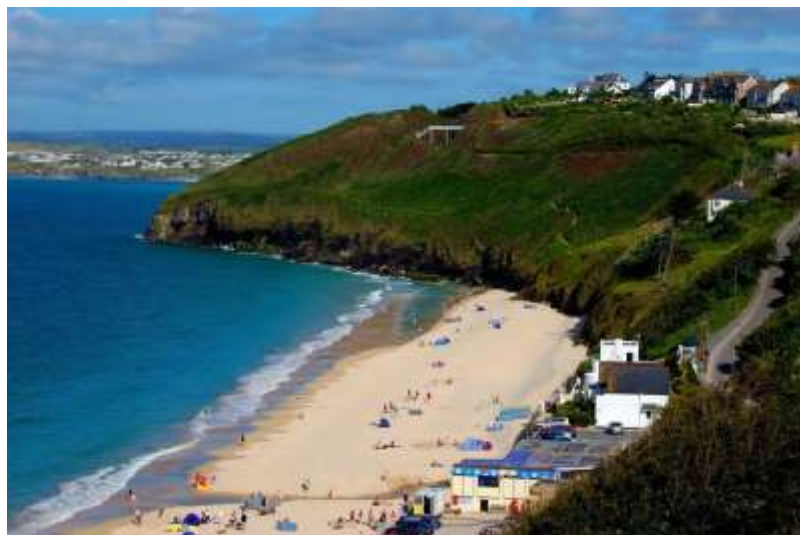
The beach itself appears very healthy in the Victorian (c.1900) watercolour, and yet the extent of the beach today (Figure 3F.12) matches precisely the historical image. This suggests that there has been relatively little coastal change over the last 114 years.

Figure 3F12: Present day view. Courtesy of T.Bakes (Panoramio.com).

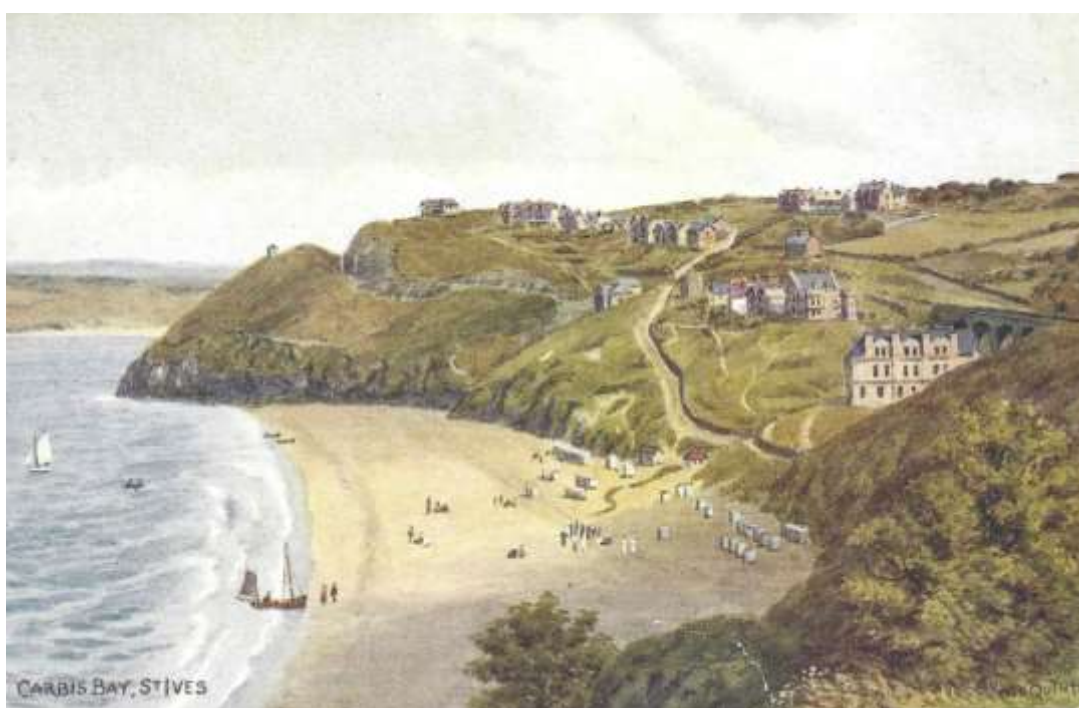
The watercolour drawing by Alfred Robert Quinton (Figure 3F.13) depicts the view from Porthminster Point, looking across Carbis Bay towards Carrick Gladden. It shows the relatively undeveloped nature of the bay at the time, and also precisely defines the extent of the beach at Low Water.

A further point of interest is the comparatively bare coastal slopes, which are now heavily vegetated. Watercolour drawings up to this date can be particularly useful in terms of comparing vegetation patterns, particularly as they represented the only images in colour available at that time, prior to the widespread introduction of colour photography in the early twentieth century.

Figure 3F13: Carbis Bay, St Ives by Alfred Robert Quinton; c.1900. Image courtesy of J. Salmon limited.

Figure 3F.13 provides an exact depiction of coastal conditions in 1920 at Carbis Bay. It allows those interested in coastal management to understand what conditions were like long before the days that monitoring programmes for beaches were put in place. Alongside the coastal risk management issues these images also describe environmental and developmental change over the intervening period.
